Melbourne Property Inspections P/L

Residential Pre-purchase Inspection Report

Date of inspection: Sunday, 01 February 2009 01:45 PM

Property address	7 XXXXXXXX Street GLEN IRIS VIC 3146
Report prepared for	Sample Sample XXXXXXX Street MOONEE PONDS VIC 3039
Client's contact details	Mobile 1234 567 890 Home (03) 7345 6789 homebuyer@melbourne.com.au
Real estate agent's details	Name XXXXXXXX XXXXX Company XXXXXXXX XXXXXXXX Mobile 1234 567 890 Office (03) 1234 5678
Type of inspection report	Standard Inspection, Complete
Persons present	Pest Inspector, Agent's Representative
Weather Conditions	Fine
Inspector	Joseph Noto, BA App. Sci. (Construct. Mgt) (Eco.) Domestic Builder - Unlimited DB-U 28857

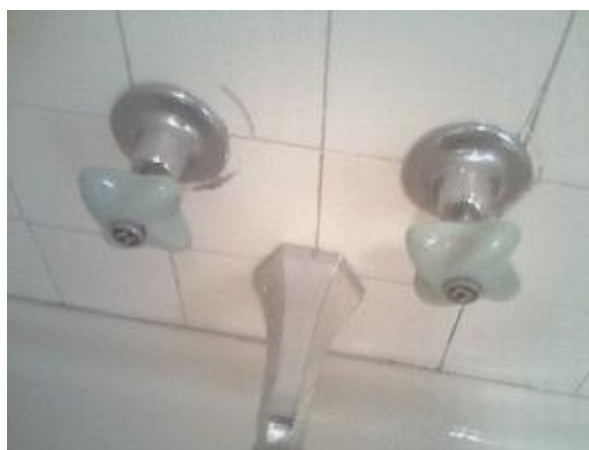
Bath taps Seized hot tap Further Investigation Type: A

Further investigation required by a licensed plumber.

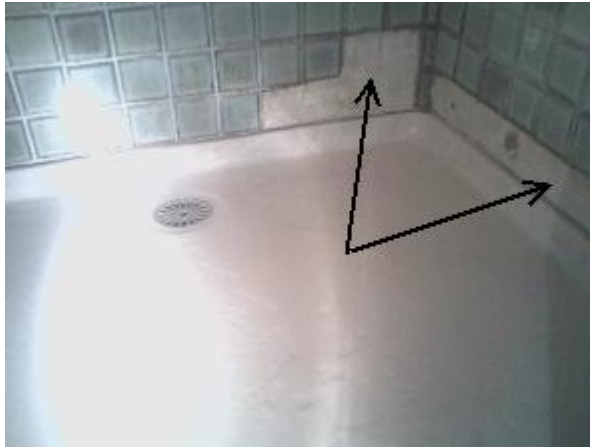
Shower tiles Missing Minor Defect Type: A

Water egress can cause rot to structural timber frame and sub-floor structure. Tiles should be re-applied and silicone sealant should be applied. Occurs to the shower in the laundry area.

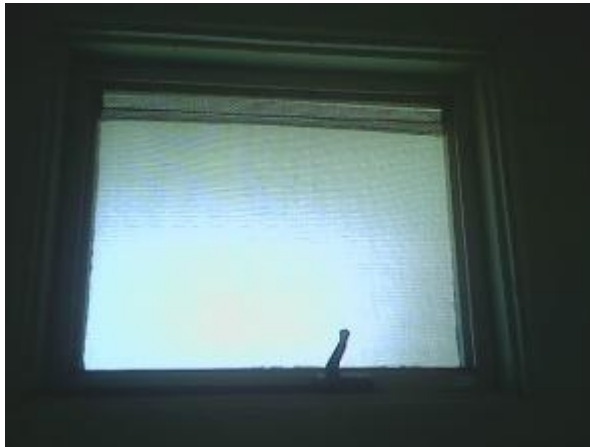
Windows Out of square Minor Defect Type: A

Timber framed windows commonly shrink and expand through the warm and cold seasons and this may be the case in this particular example. However, this defect has more probably occurred as a result of movement in the foundations and the sub-floor structure of the home. The cracking between the windows is further testament of sub-flor structure movement transferring through the wall frames and it affect on this particular window. Refer to the relevant photo under Bathroom - Walls - Cracking category 1.

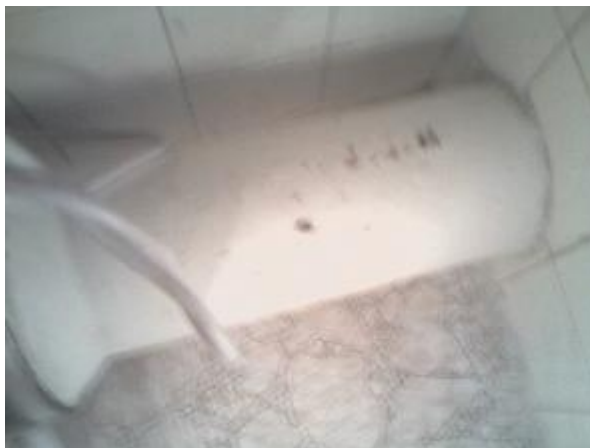
Waste pipes Corroded Further Investigation Type: D

Waste pipe to toilet in main bathroom has corroded and may require replacement in the near future. Further investigation is required by a licensed plumber.

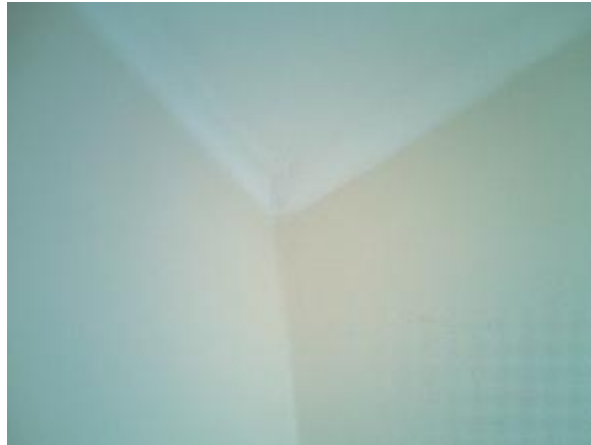
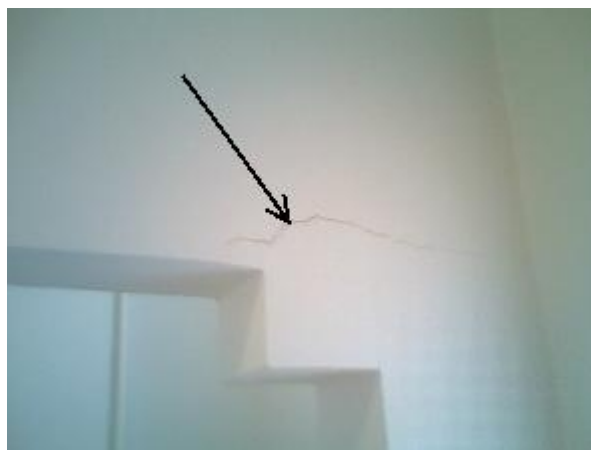
Walls Cracking - category 1 Minor Defect Type: A

Movement of the sub-floor structure has transferred through to internal walls resulting in minor cracking to plastered finishes. Additionally, rectification works are required to the sub-floor area. Please refer to the sub-floor section of this report.

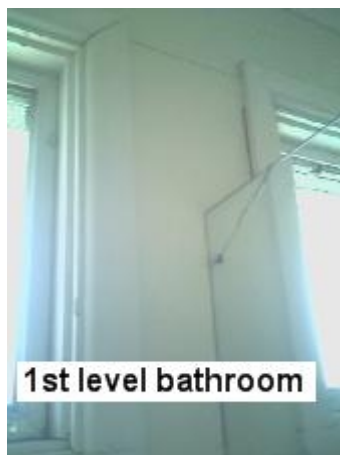
Doors and frames

Door frame out of square

Minor Defect

Type: A

Movement in the sub-floor structure has caused this defect. Movement of the timber wall frame has occurred and as door frames are connected to the wall frame this particular door has moved out of square to the point where it does not fully shut.

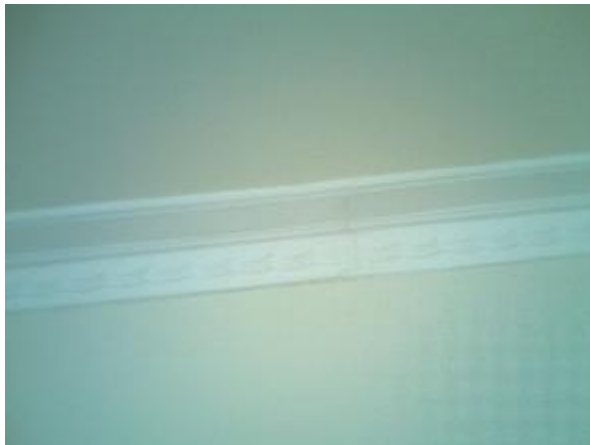
Ceilings & cornices Cornice corner separation/splitting Minor Defect Type: A
Movement of the sub-floor structure has created movement through the timber frame resulting in cracking to the internal plasterboard linings. Although this crack is minor, any crack should be monitored regularly. Refer to the sub-floor section of this report.

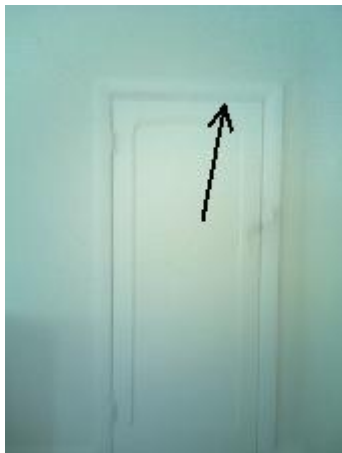
Doors and frames Door frame out of square Minor Defect Type: A
Movement in the sub-floor structure has caused this defect. Movement of the timber wall frame has occurred and as door frames are connected to the wall frame this particular door has moved out of square to the point where it does not fully shut.

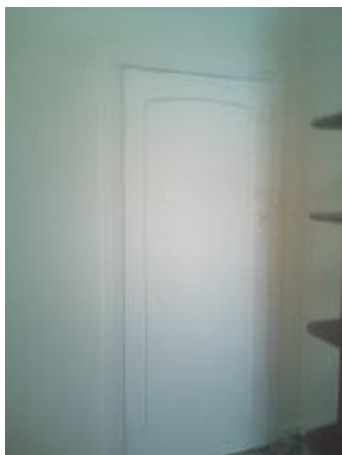
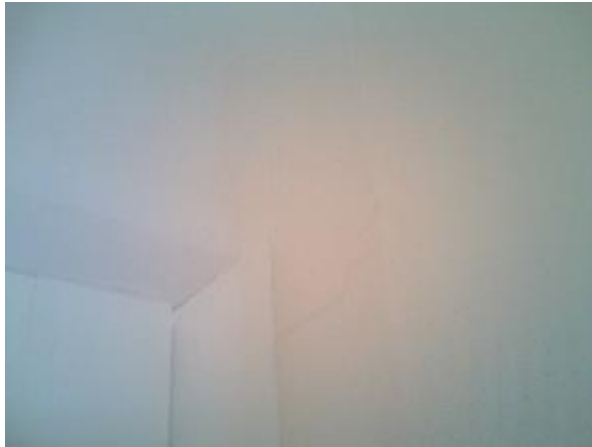
Walls Cracking - category 1 Minor Defect Type: A
Movement of the sub-floor structure has transferred through to internal walls resulting in minor cracking to plastered finishes. Additionally, rectification works are required to the sub-floor area. Please refer to the sub-floor section of this report.

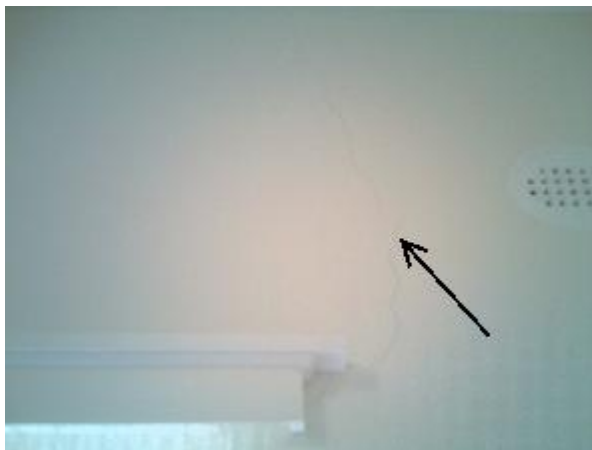
Ceilings & cornices Dampness and damp damage Minor Defect Type: C

Cracking through roof tiles was not cited. However, some tiles require re-seating. Particular storms with enough strength may force water through these tiles that require re-seating resulting in this leak.

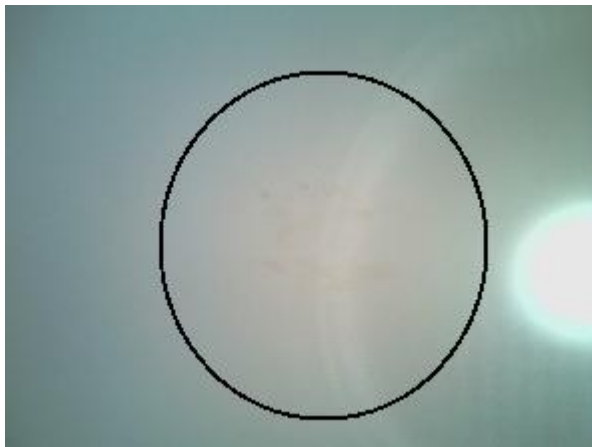
Ceilings & cornices Cornice damage Minor Defect Type: A
Movement of the sub-floor structure has created movement through the timber frame resulting in cracking to the internal plasterboard linings. Please refer to the sub-floor section of this report.

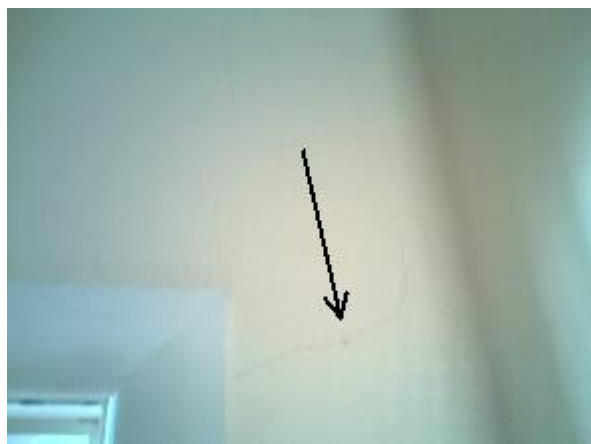
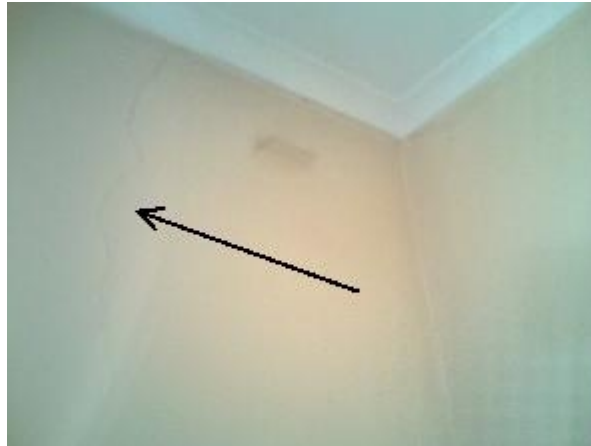
Walls

Cracking - category 2

Minor Defect

Type: A

Movement of the sub-floor structure has transferred through to internal walls resulting in minor cracking to plastered finishes. Additionally, rectification works are required to the sub-floor area. Please refer to the sub-floor section of this report.

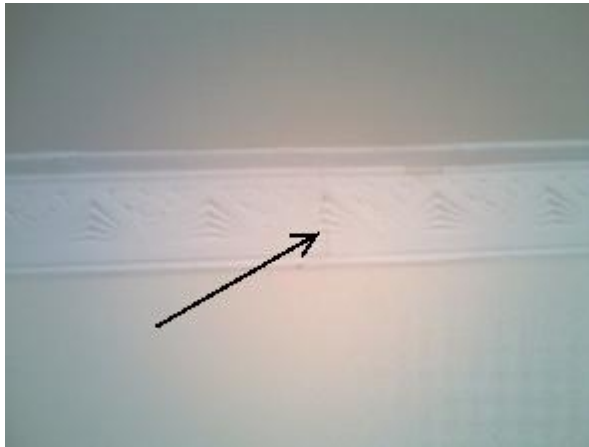
Minor Defect

Type: A

Movement of the sub-floor structure has created movement through the timber frame resulting in cracking to the internal plasterboard linings. Refer to the sub-floor section of this report.

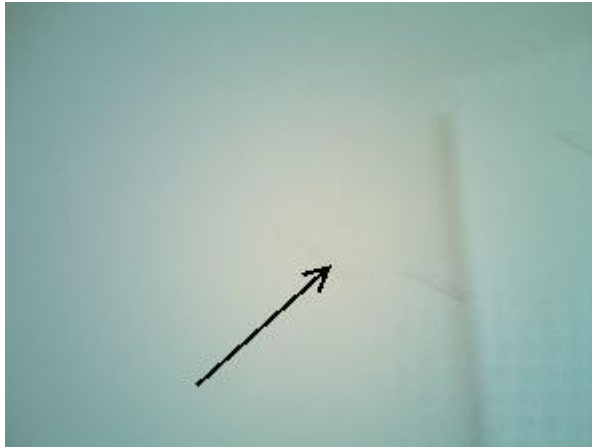
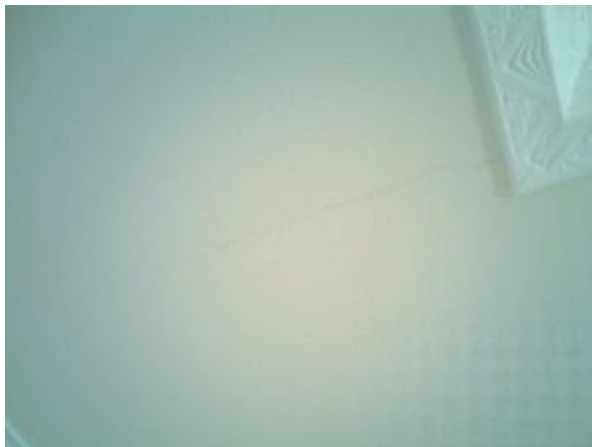
Ceilings & cornices Cracking Minor Defect Type: A

These cracks have most probably occurred due to the 1st level extension. Where additional dead or wind loads may have created movement to ceiling joists. Additionally, the movement in the sub-floor area may have also created this defect. Please refer to the sub-floor section of this report.

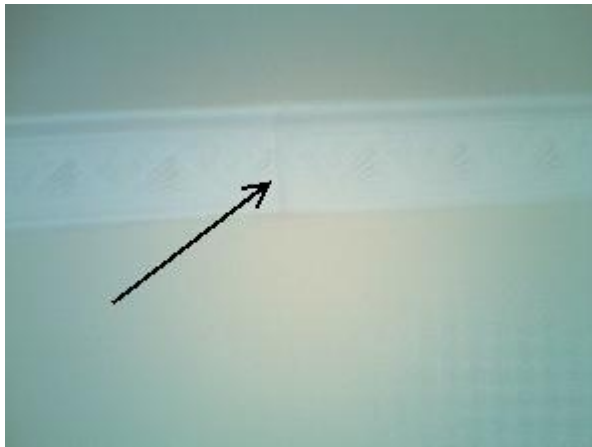
Ceilings & cornices

Cornice damage

Minor Defect

Type: A

Movement of the sub-floor structure has created movement through the timber frame resulting in cracking to the internal plasterboard linings. Please refer to the sub-floor section of this report.

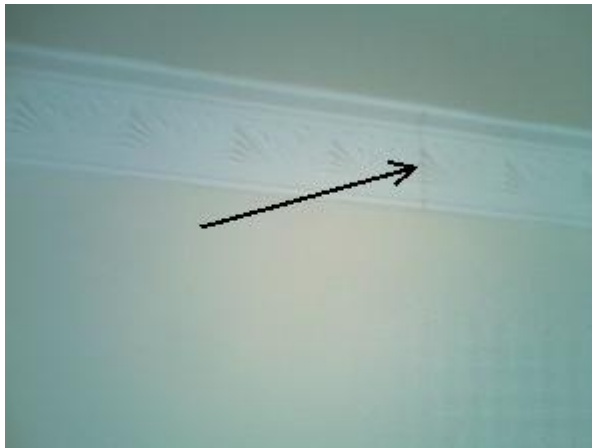
Walls Cracking - category 2 Minor Defect Type: A

Movement of the sub-floor structure has transferred through to internal walls resulting in minor cracking to plastered finishes. Additionally, rectification works are required to the sub-floor area. Please refer to the sub-floor section of this report.

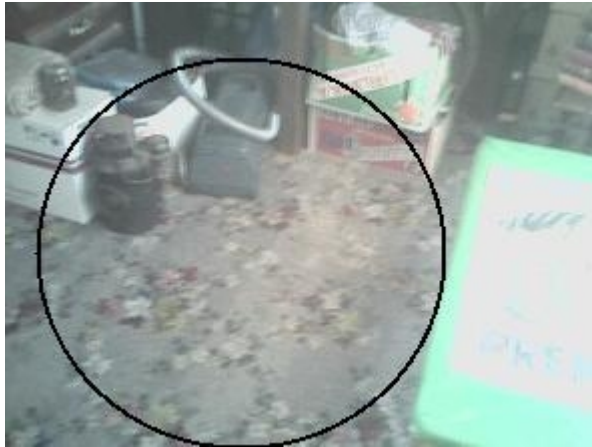
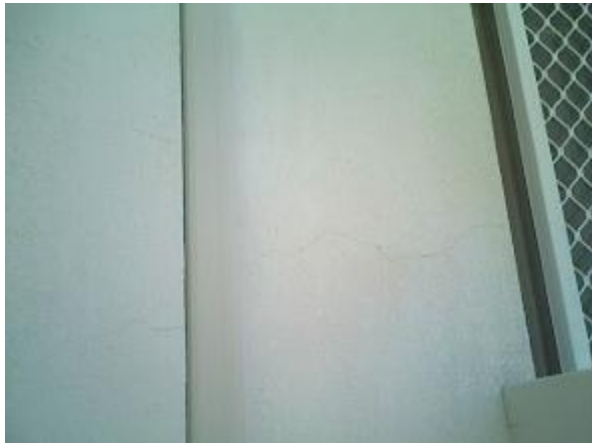
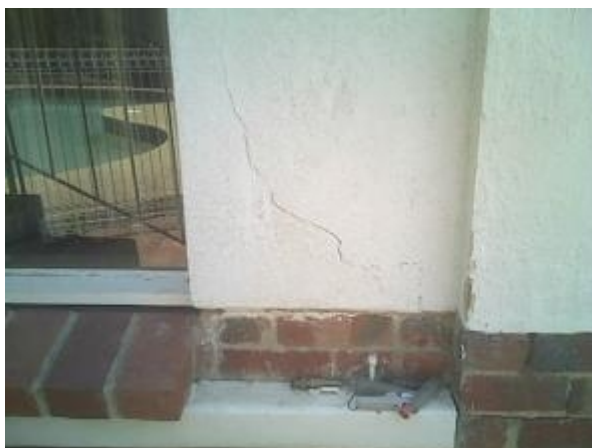
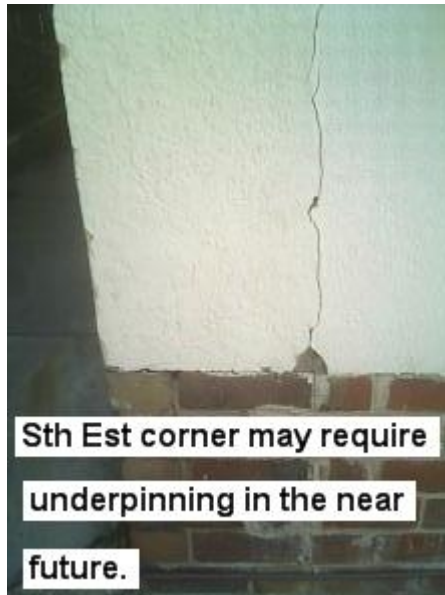
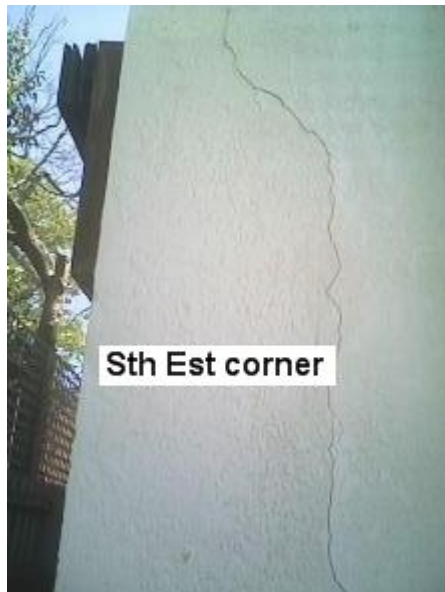
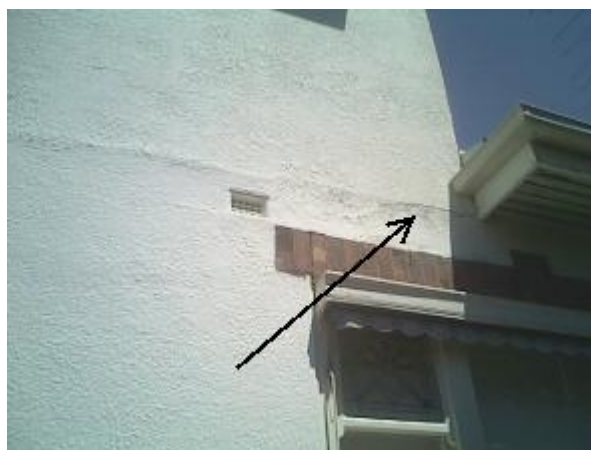
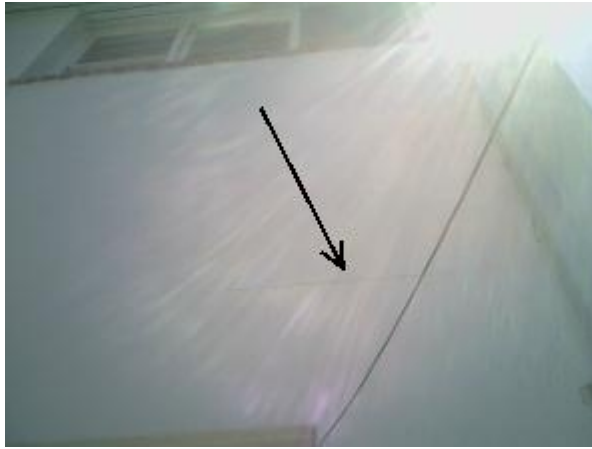
Walling

Cracking - category 2

Minor Defect

Most cracks depicted fall within the Category 2 or below cracking code. All cracks have been caused by movement of foundations. These conditions are known as abnormal conditions for the concrete footings or stumps to operate in and unfortunately create cracking to internal and external brick and plasterboard linings.

At this stage underpinning to the walls shown on these photo's is not required, however, regular monitoring should take place and further assessment should take place if cracks continue to open.

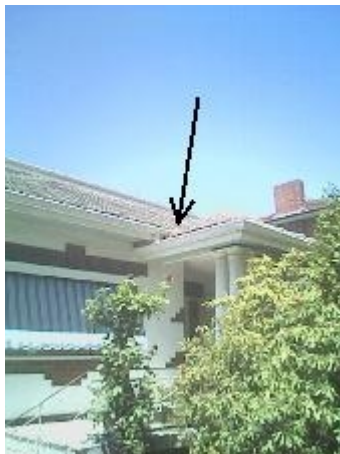
Items in roof space Asbestos flue Further Investigation Type: F
Possible asbestos flue. Further investigation required by a licensed asbestos inspector.

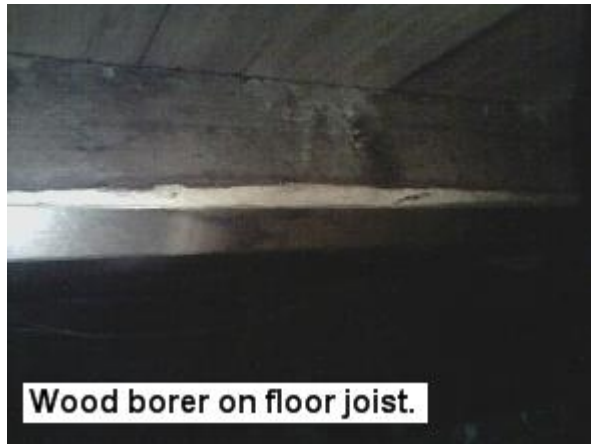
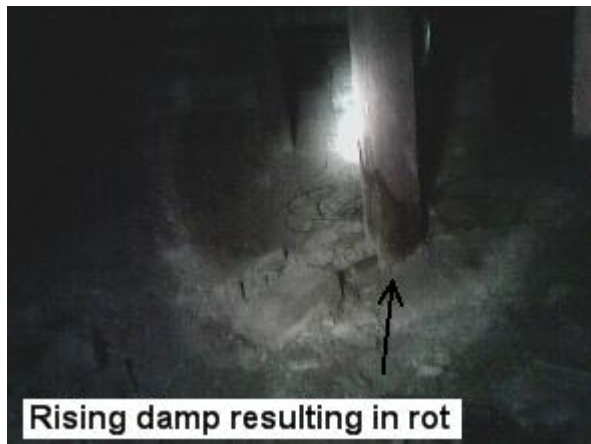
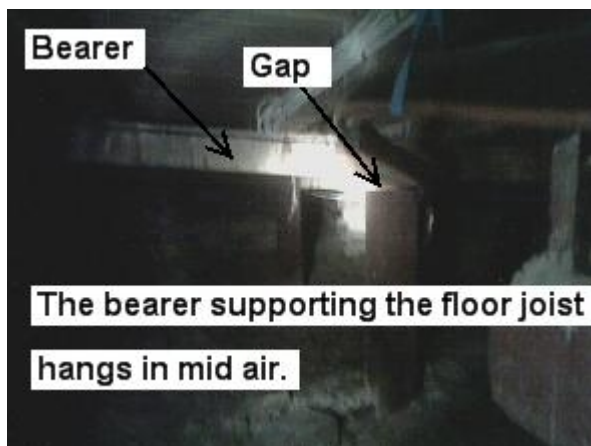
Under timber floor

Rot to under floor timbers

Major Defect

Type: D

Timber stumps are rotted through at their bases. Re-stumping is required to all area's of the sub-floor. In particular instances stumps have subsided and/or moved severley off plumb. In these instances the floor bearers hang in mid air without any support from the stump. This has caused excessive movment through the timber frame of the home causing defects such as out of level floors, door & window frames becoming out of square and cracking to internal plastered and plasterboard linings.
