Melbourne Property Inspections P/L

Residential Pre-purchase Inspection Report

Date of inspection: Tuesday, 10 February 2009 12:00 PM

Property address	X/XX-XXX Xxxxxxx Street MORDIALLOC VIC 3195
Report prepared for	Xxxxxxxxx Sample 52 Xxxx Xxxx Avenue MORDIALLOC VIC 3195
Client's contact details	Mobile 4567 890 222 xxxxxxxx@three.com.au
Real estate agent's details	Name Xxxx Xxxxxxx Company Xxxxx Xxxxxxx
Type of inspection report	Standard Inspection, Complete
Persons present	Client
Weather Conditions	Fine
Inspector	Joseph Noto, BA App. Sci. (Construct. Mgt) (Eco.) Domestic Builder - Unlimited DB-U 28857

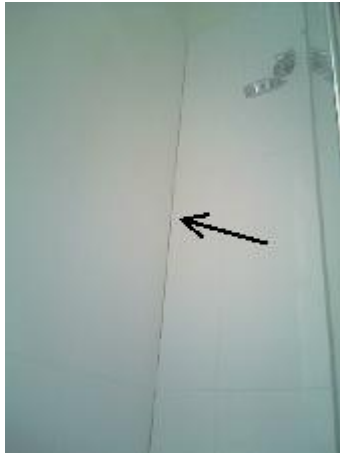
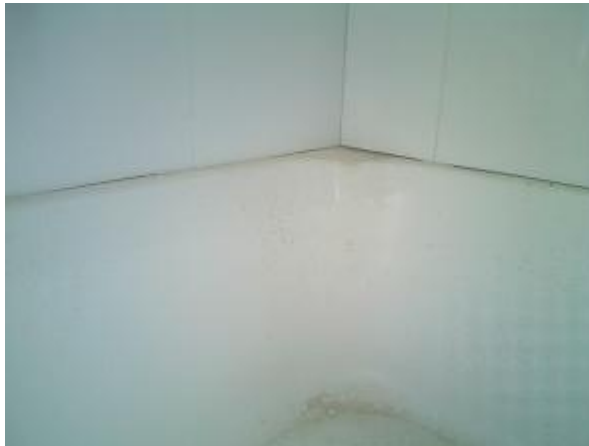
Tiles Grouting missing Minor Defect Type: F

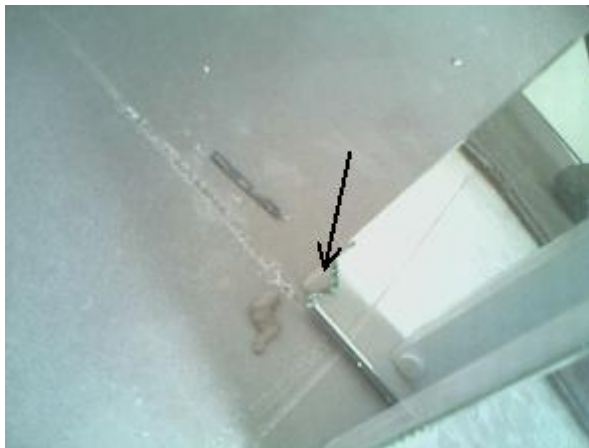
Built in robe/cupboard Damage glass to over head cupboard Minor Defect Type: A
Requires replacement.

Requires replacement.

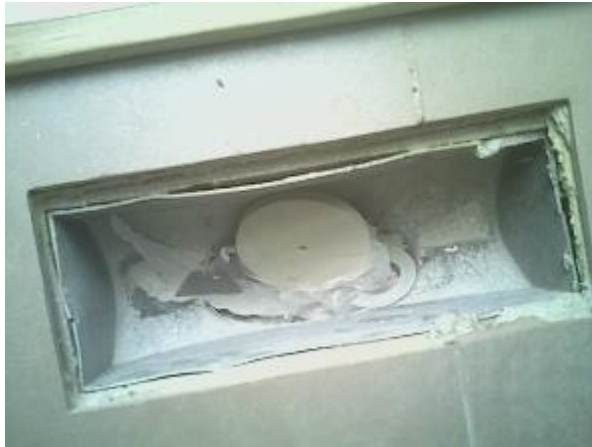
Heating vents Require cleaning Minor Defect Type: A
Building rubbish requires cleaning. Occurs to many rooms.

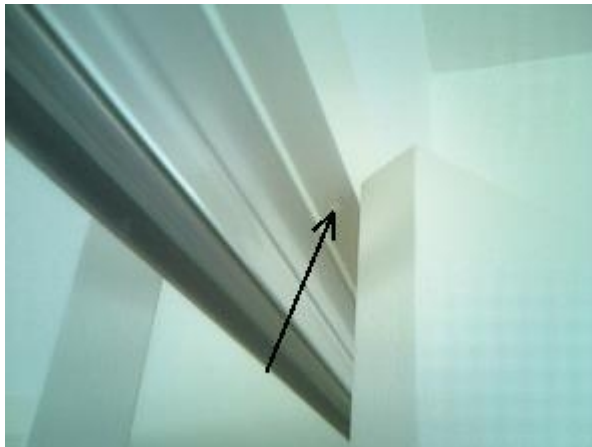
Doors and frames Missing door stops resulting in damage Minor Defect Type: F
Damage has been created to the architrave of the built in robe as a door stop has not been installed. Door stops require installation to most rooms.

Damage has been created to the architrave of the built in robe as a door stop has not been installed. Door stops require installation to most rooms.

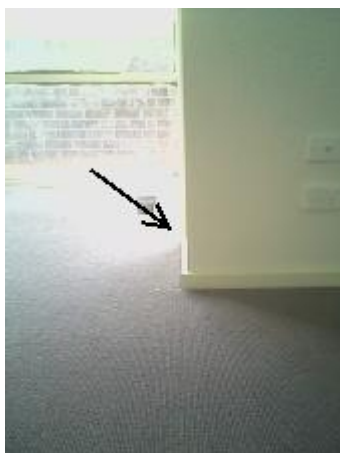
Walls Bow vertically Minor Defect Type: A
Internal plasterboard wall is bowed vertically. It seems as though this wall has not been straightened.

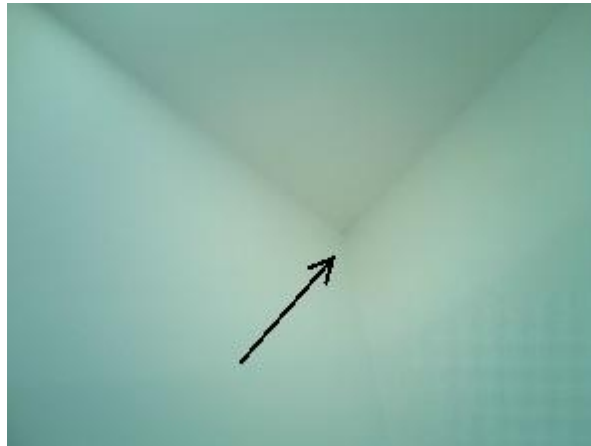
Ceilings & cornices Cracking Minor Defect Type: A

Movement of the sub-floor structure has created movement through the timber frame resulting in cracking to the internal plasterboard linings. Although this crack is minor, any crack should be monitored regularly and re-assessment should be carried out if the crack widens.

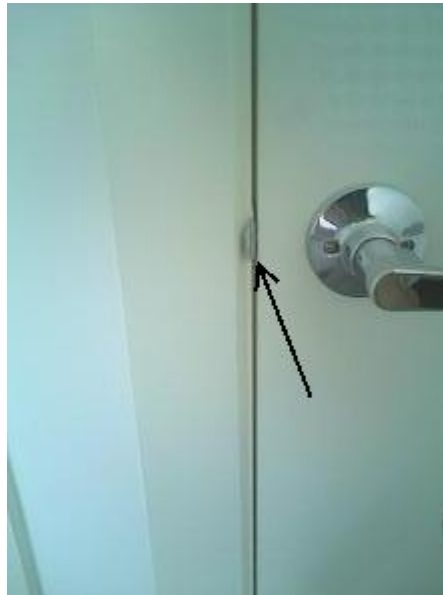
Defective door hardware

Door does not latch.

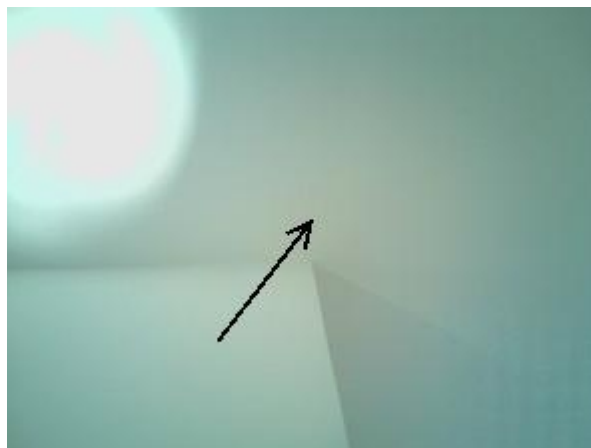
Ceilings & cornices Cracking Minor Defect Type: A

Movement of the sub-floor structure has created movement through the timber frame resulting in cracking to the internal plasterboard linings. Although this crack is minor, any crack should be monitored regularly and re-assessment should be carried out if the crack widens.

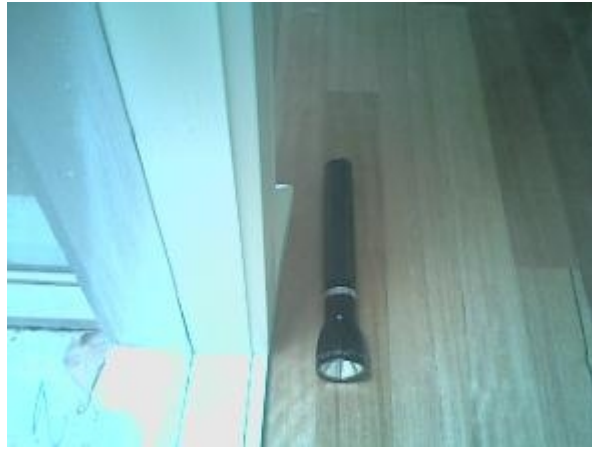
Walls Bow vertically Major Defect Type: A

Rectification works are required. Installation of structural beyond the plasterboard and skirting does not satisfy Australian standards.

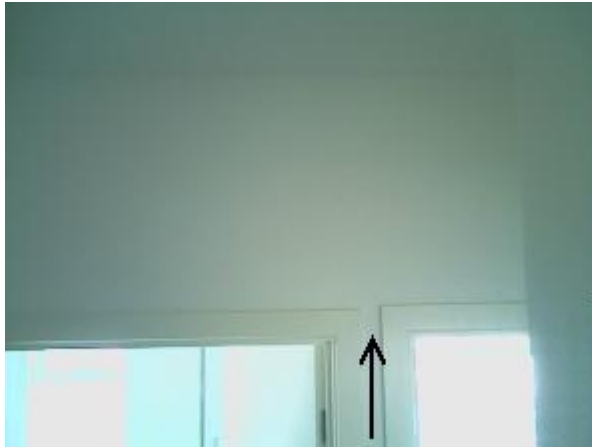
Doors and frames Architraves set at different levels Minor Defect Type: F
Architraves to bathroom, Bed 2 & Bed 3 are set at different levels and should be fixed.

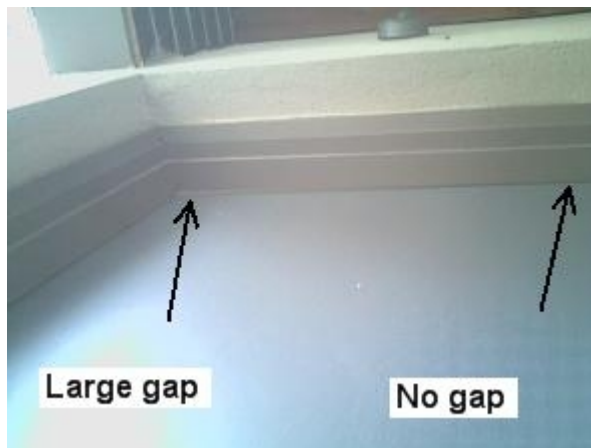
Door frame out of square

Door frame out of square as the surrounding wall frames are out of square.

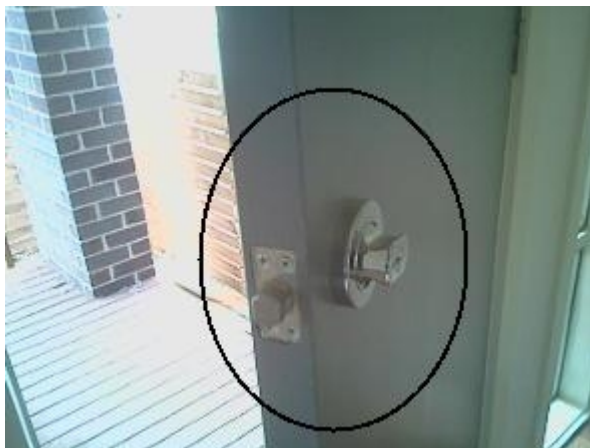
Missing door hardware

Further inspection will be required by the building surveyor as to the safety issues or regulations in the BCA.

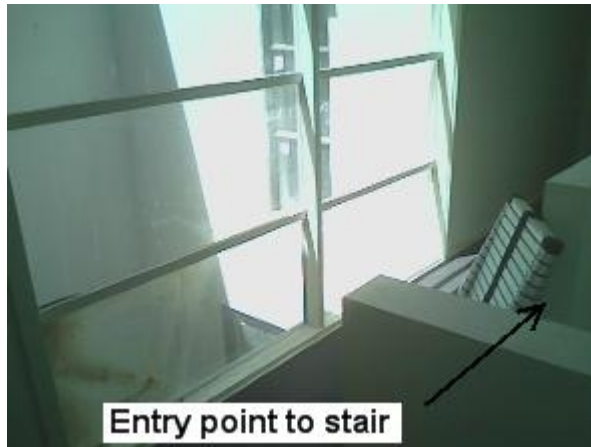
Glass does not seem to be to safety standard for this application

The building surveyor needs to be contacted to check the BCA requirements for this application. The glass is not double glazed as it is down stairs through the light well and does not seem thick enough to withstand the weight of a child who may be off balance falling into the glass.

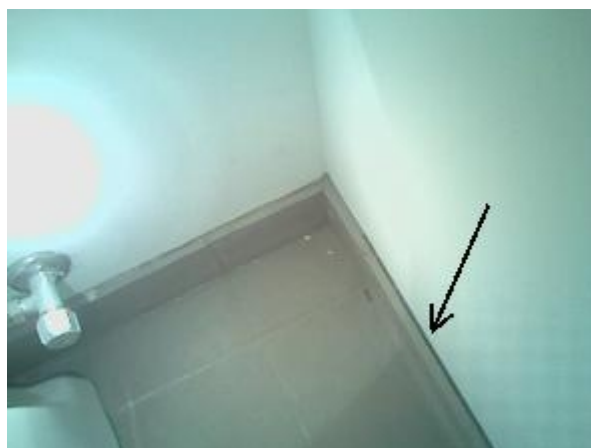
WC tiling Gap between skirting tile and plasterboard wall Minor Defect Type: F

A slight bow in the wall exists and presumably walls have not been straightened. Caulking of this gap is required in any case.

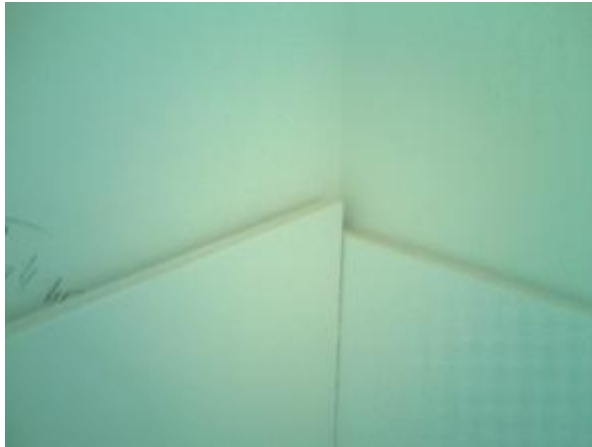
WC tiling Uneven tiling Minor Defect Type: F

A mirror is to be inserted to the wall above the wash basin, however, tiles are laid out of level.

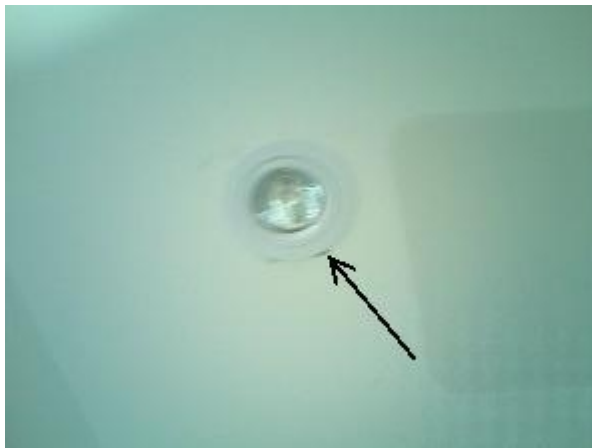
Ceilings & cornices
Requires patching.

Torn sheet at downlight

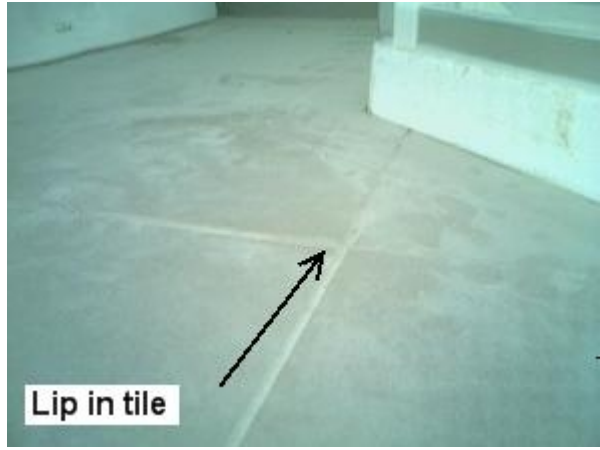
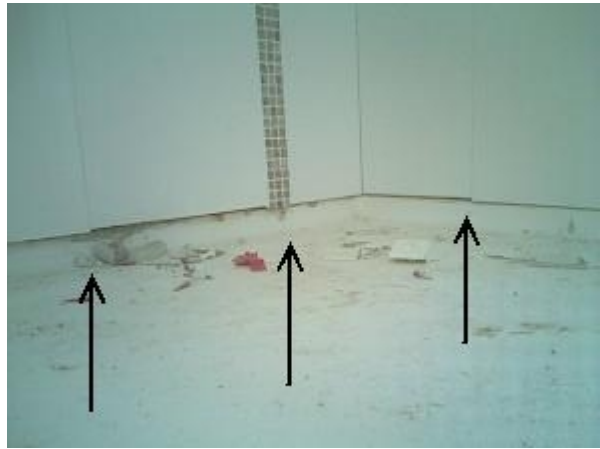
Tiles Uneven tiling Minor Defect Type: F
Rectification will involve re-tiling.

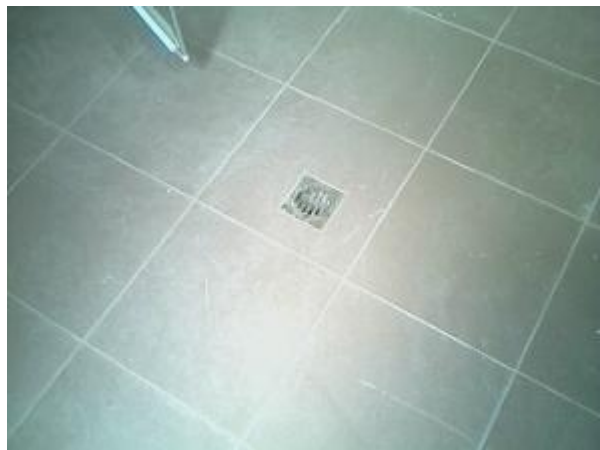
Fall into waste point No fall into waste point Minor Defect Type: F
Extensive repair works will be required to gain fall into this waste point. Tiles will need to removed etc.

Extensive repair works will be required to gain fall into this waste point. Tiles will need to be removed etc.

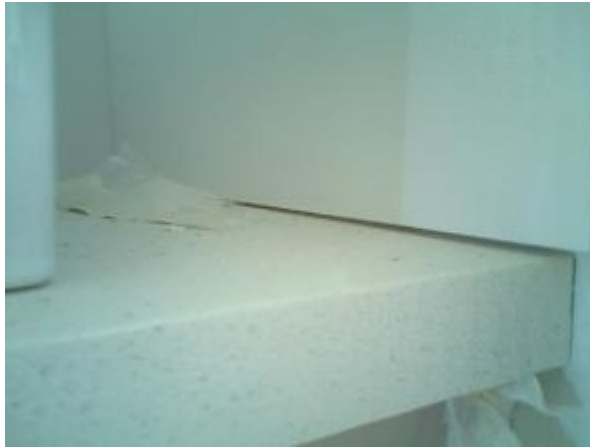
Benchtop Not level Minor Defect Type: F

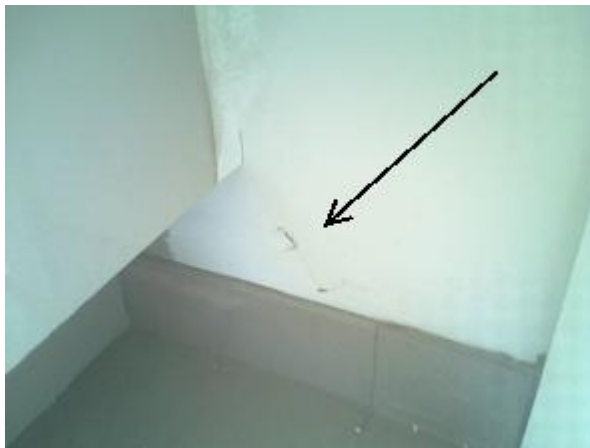
Damage

Plasterboard has been knocked and requires repair.

Plasterboard has been knocked and requires repair.

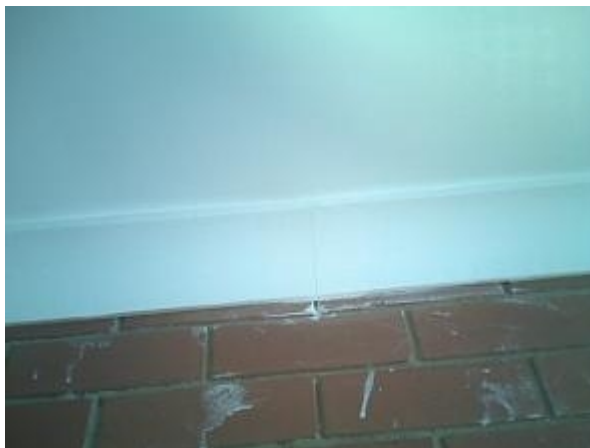
Damaged cornice

Has occurred due to settlement of foundations. Cracks should be monitored regularly and if widen to approx. 10mm should be re-assessed as possible rectification work may be required.

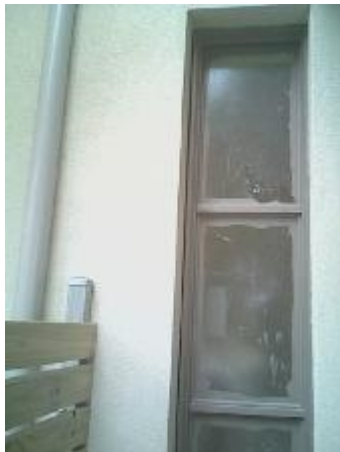
Windows	Gapping between edge of window & reveal	Minor Defect	Type: F
---------	---	--------------	---------

Window frames have been installed hard up against one side of the opening and not centred within the opening, as a result large gap on one side of the window is apparent. Where this defect occurs windows should be re-installed centrally so that an even gap appears around the window frame for caulking.

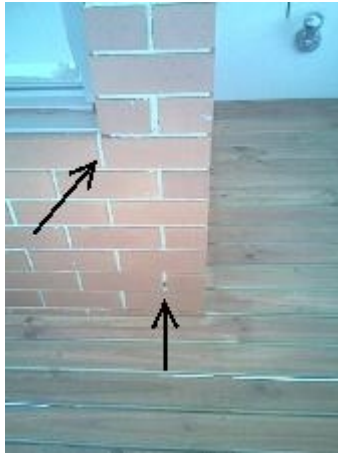
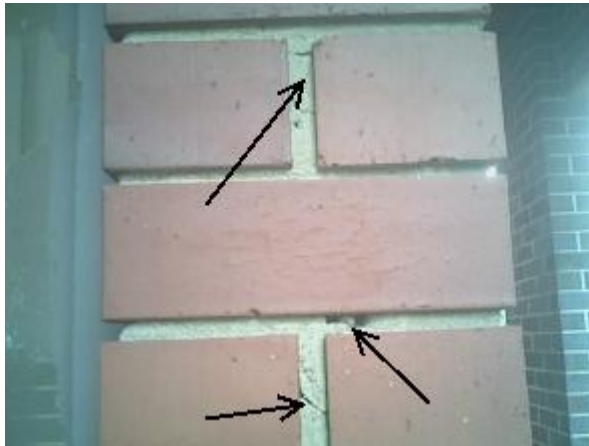
Walling	Cracking and missing mortar	Minor Defect	Type: A
---------	-----------------------------	--------------	---------

Poor sand/cement/lime ratio often causes this defect to occur. Re-pointing is required.

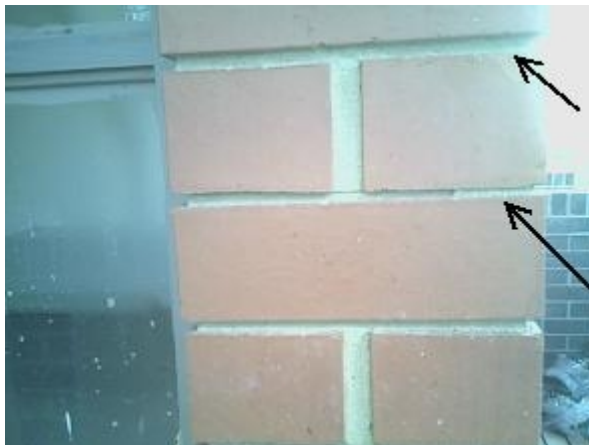
Walling Masonry out of required tolerance for bed joints Further Investigation Type: F

A pre-purchase inspection report cannot make comment on the Australian Standards for particular trades or services relevant to a building site, however, deviation of a bed joint from horizontal or of that specified in elevation cannot be more than + or - 3mm. This brickwork is not to standard. Occurs in other locations.

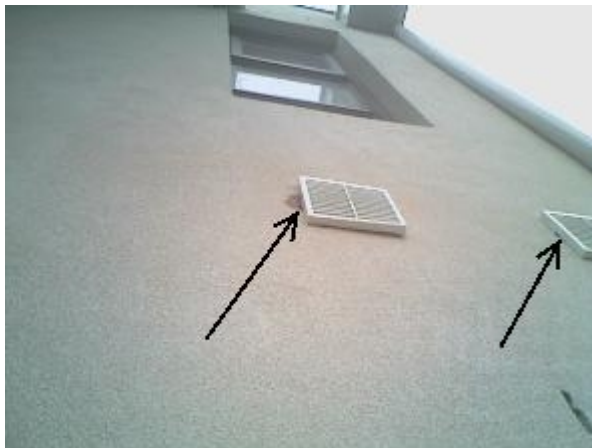
Damage to brick veneer

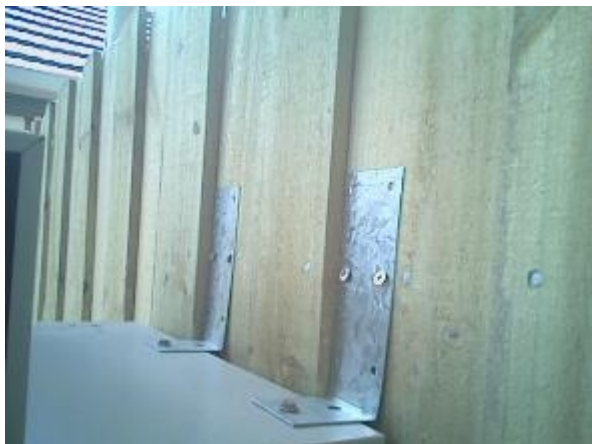
Hot water service has been connected to a timber palling fence which acts as a boundary wall. The boundary wall is flimsy and will move constantly in the wind. Gas and water service pipes run through holes drilled through the timber decking. Movement may cause pipe connections to loosen over time causing leaking.

A licensed plumber should be contacted to make further inspection and advise on regulatory issues with this installation.

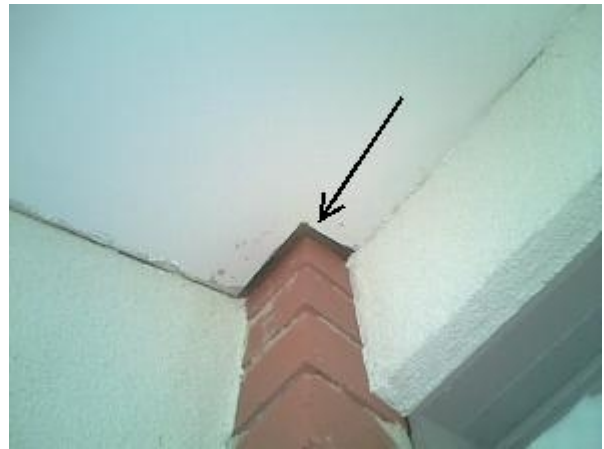
Balcony soffit Soffit lining cut short Minor Defect Type: F
A quad will now be required as opposed to a silicone sealed finish.

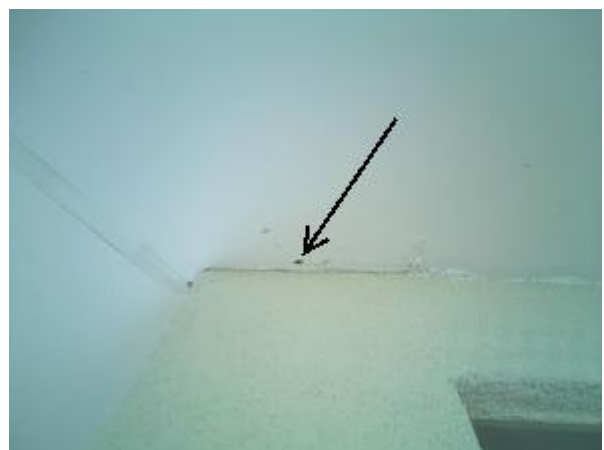
Balcony soffit Damaged lining Minor Defect Type: A

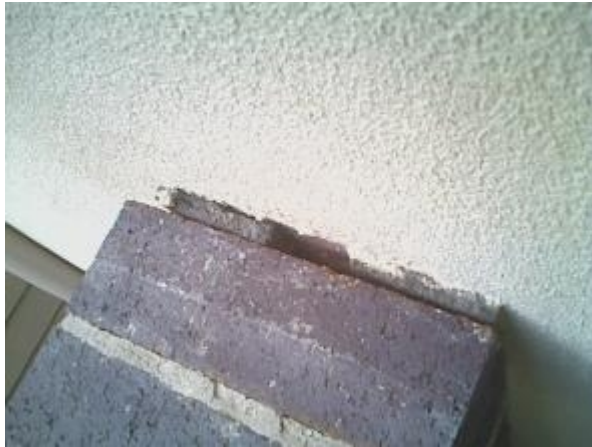
Balustrade Caulking required Minor Defect Type: F
Occurs at both ends of balcony.

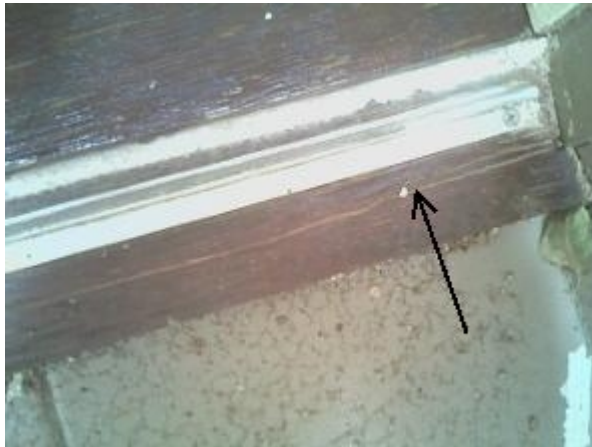
Door sills Cracked Minor Defect Type: A

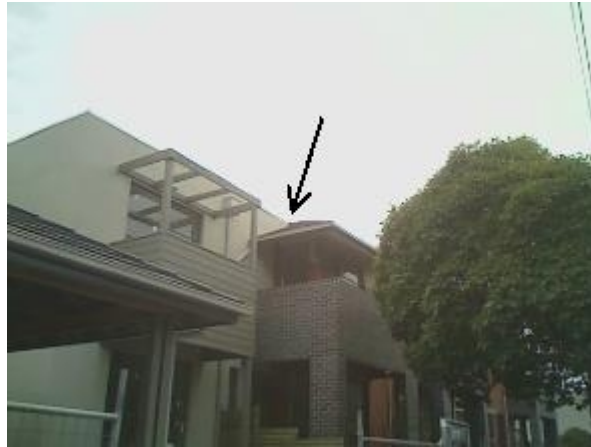
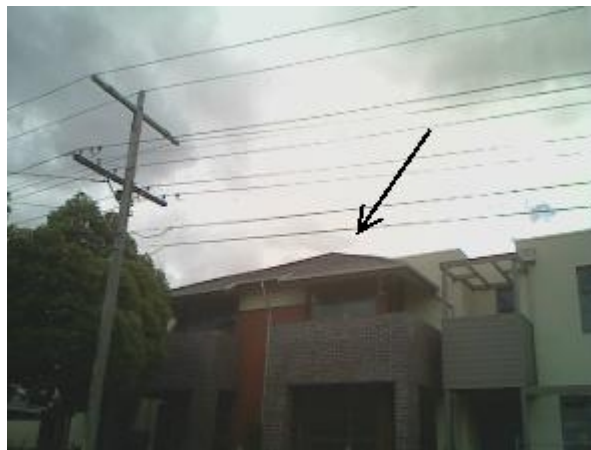
Roof tiles Capping tiles are bowed Minor Defect Type: F

Installation of bowed timber to the roof framing and poor workmanship in laying ridge tiles have resulted in this defect.

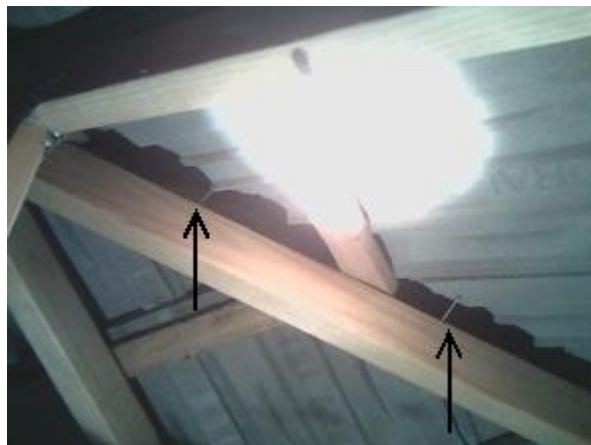
Roof framing Insufficient framing Minor Defect Type: F

Roof battens are insufficient and in this case roof tiles close to the ridge have been supported by nails tacked into the roof frame.

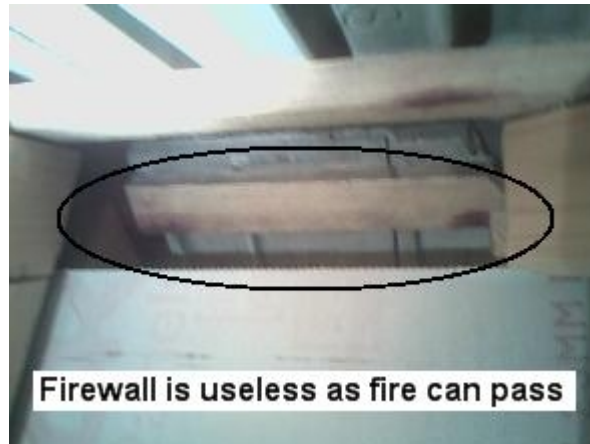
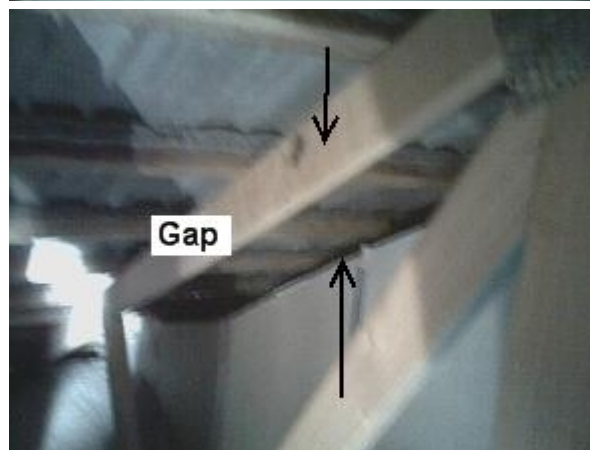
Fire wall Gap between top of fire wall & underside of roofing to seal Minor Defect Type: F

Fire wall has not been built into the underside of the roof. This should not have passed the mandatory inspection. Requires replacement.

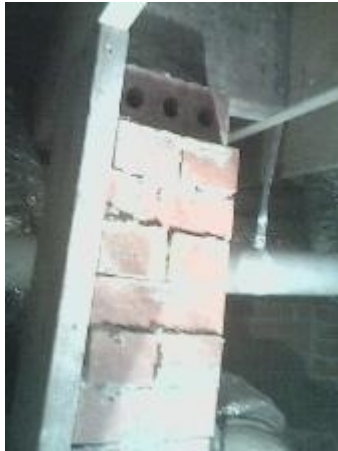
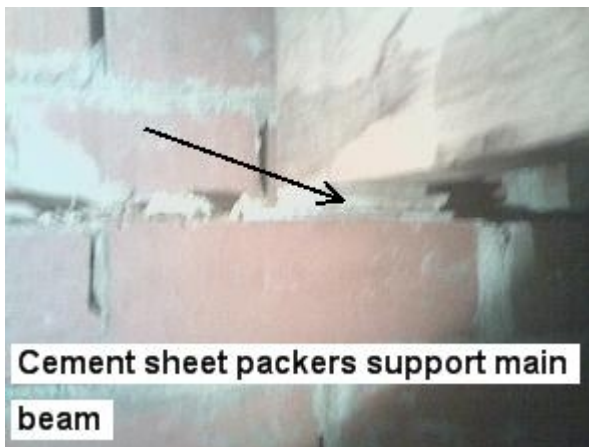
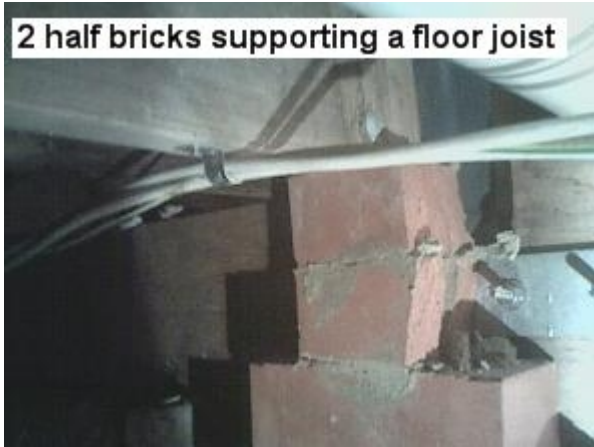
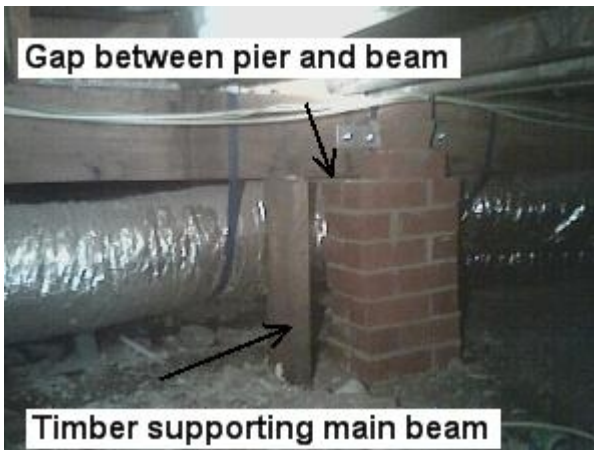
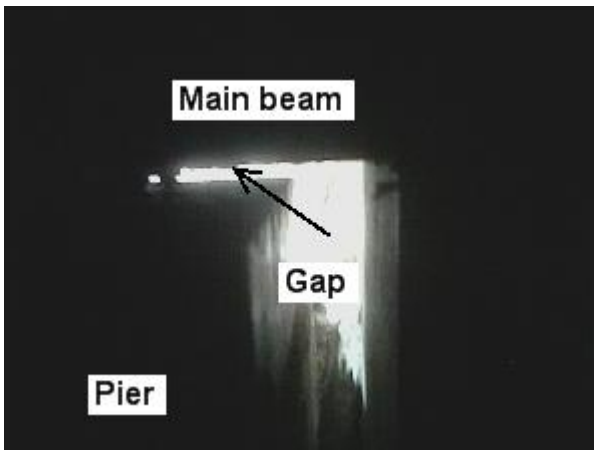
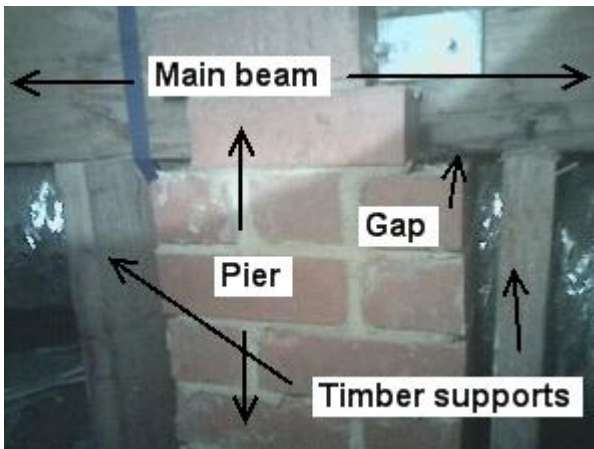
Masonry Piers

Major Defect

Masonry piers do not bear the load of the main beam running through the sub-floor. In one instance cement sheet packers to approx. 1 inch in height sit between the pier and the beam and in other examples the beam is supported by timber either side of the pier. These defects should not have been passed at the mandatory frame stage inspection. Please refer to the photo's below.

Sub-floor structure defects are a major concern. Consultation with a registered building surveyor should be carried out.

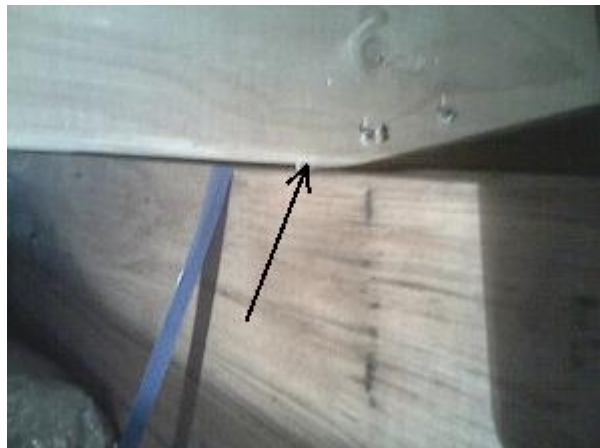
Gapping between main beam and floor joists

May create squeaking over time.

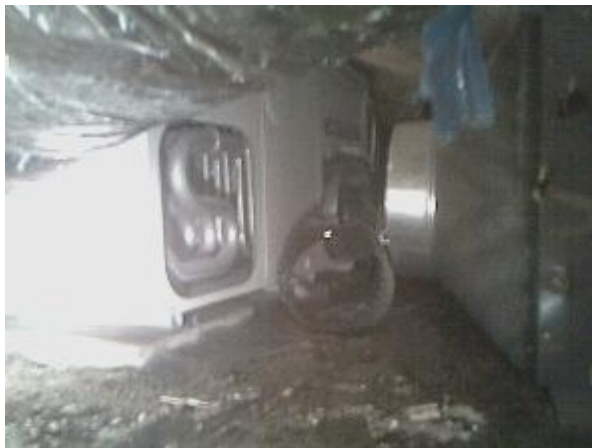
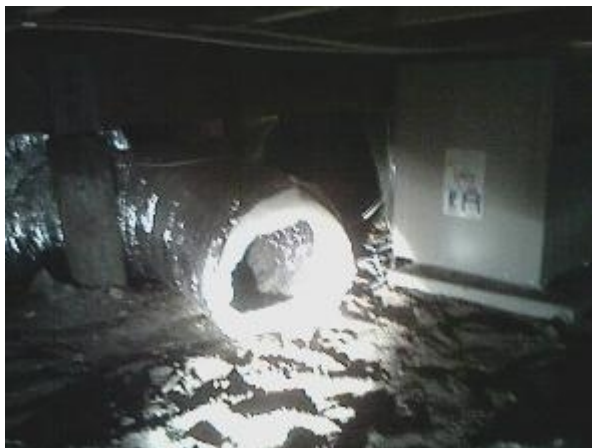
Air conditioning system Ducts not connected
Require connection before commissioning.

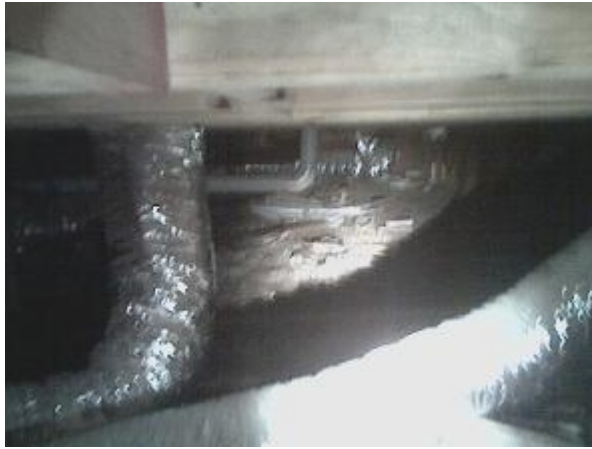
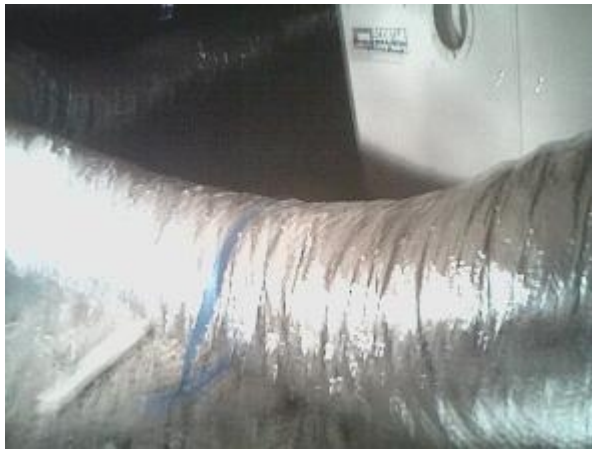
Air conditioning system Ducts run along ground
Ducts will decay if left on natural ground.

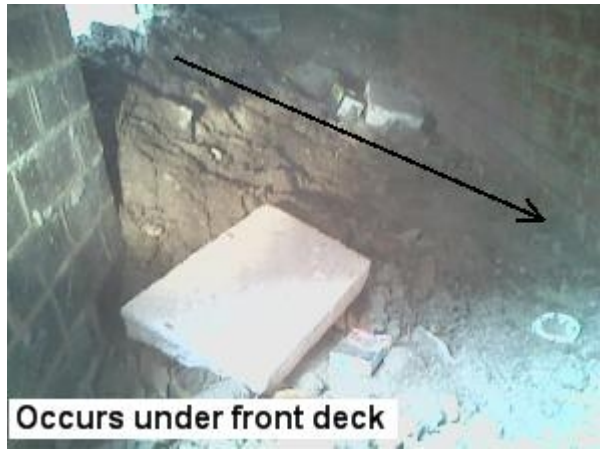
Surface water No grade away from perimeter path Minor Defect Type: F
edges or provision for drainage
Earth should be graded away from the building to prevent water damage related defects.
