# Melbourne Property Inspections P/L

## Residential Pre-purchase Inspection Report

Property address	23 Sample Terrace POINT COOK VIC 3030
Report prepared for	Peter Sample 25 Sample Terrace POINT COOK VIC 3030
Client's contact details	Mobile 0000 000 000 <a href="mailto:sample@sample.com">sample@sample.com</a>
Real estate agent's details	Name Company N/A
Type of inspection report	Standard Inspection, Defect Only
Persons present	Builder's representative, Client
Weather Conditions	Fine
Inspector	Joseph Noto, BA App. Sci. (Construct. Mgt) (Eco.) Domestic Builder - Unlimited DB-U 28857

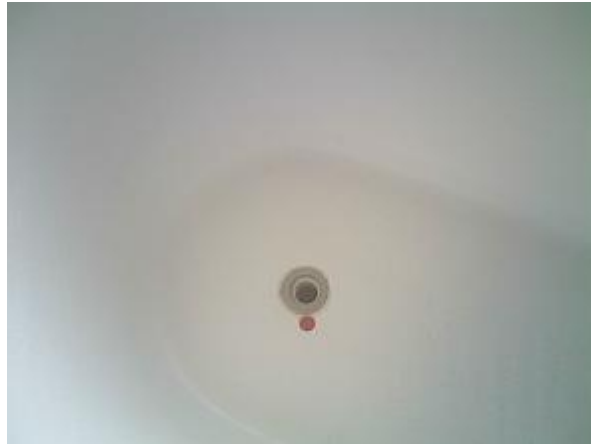
Bath                      Drainage cap missing                      Minor Defect                      Type: F

### Interior > Bathroom > Bath > Drainage cap missing

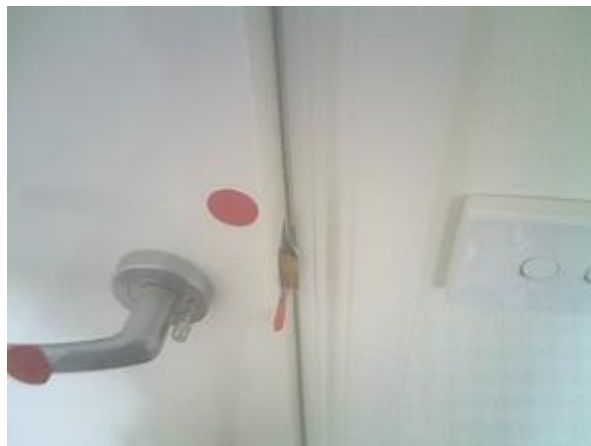
Doors and frames                      Binding doors                      Minor Defect                      Type: F  
*Doors are commonly installed incorrectly and are not trimmed before installation. Door requires trimming and re-installation. The door jamb may have been installed out of square. This is a common defect.*

Doors are commonly installed incorrectly and are not trimmed before installation. Door requires trimming and re-installation. The door jamb may have been installed out of square. This is a common defect.

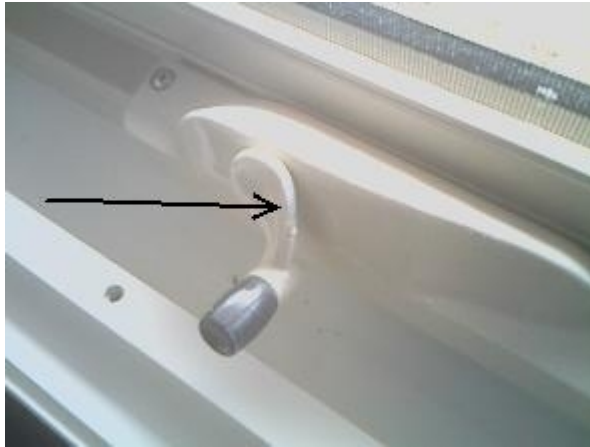
Windows                      Damaged window winder                      Minor Defect                      Type: A

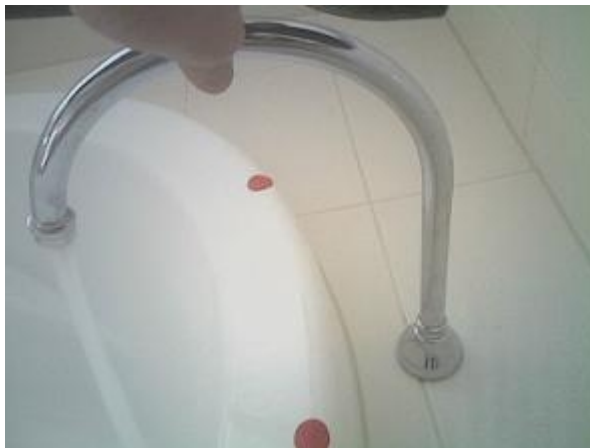
Bath taps                      Loose tap installation                      Minor Defect                      Type: F  
*This is a common issue with taps of this girth and length. Occurs to ensuite.*

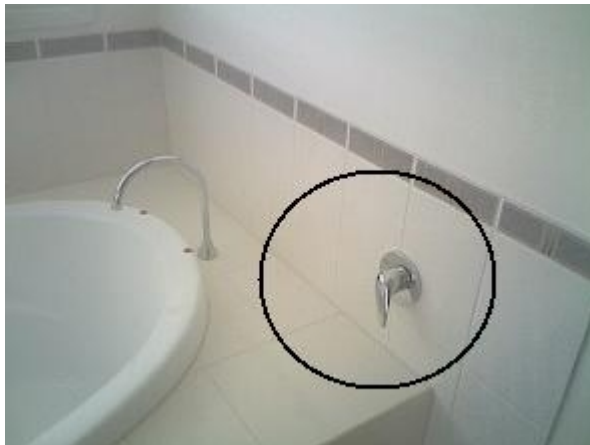
Bath taps                      Water hammer                      Major Defect                      Type: F  
*Water pipe to the bath tub exhibits water hammer. Extensive rectification work will include demolition of wall cladding, re-bracketing of pipes so they are firmly attached to the wall and re-instatement of cladding and finishes including water proofing. Occurs to ensuite.*

### Interior > Bathroom > Bath taps > Water hammer

Water pipe to the bath tub exhibits water hammer. Extensive rectification work will include demolition of wall cladding, re-bracketing of pipes so they are firmly attached to the wall and re-installation of cladding and finishes including water proofing. Occurs to ensuite.

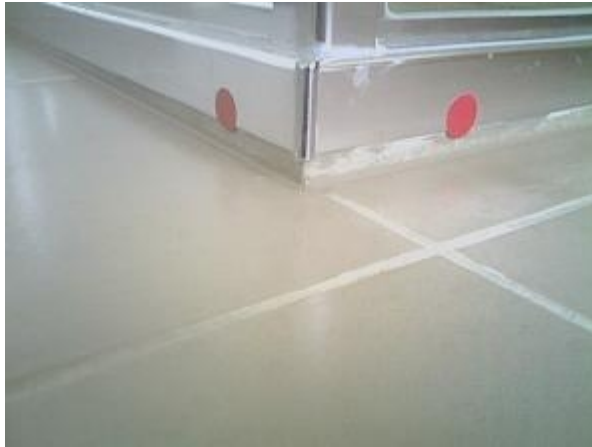
Shower screen                      Inadequate screen                      Minor Defect                      Type: F  
*Shower screen should be replaced as it does not suit the height of the hob. This may be the case on every particular home of this style unless the hob was built to high. Silicone sealant to this height is not acceptable.*

### Interior > Bathroom > Shower screen > Inadequate screen

Shower screen should be replaced as it does not suit the height of the hob. This may be the case on every particular home of this style unless the hob was built to high. Silicone sealant to this height is not acceptable.

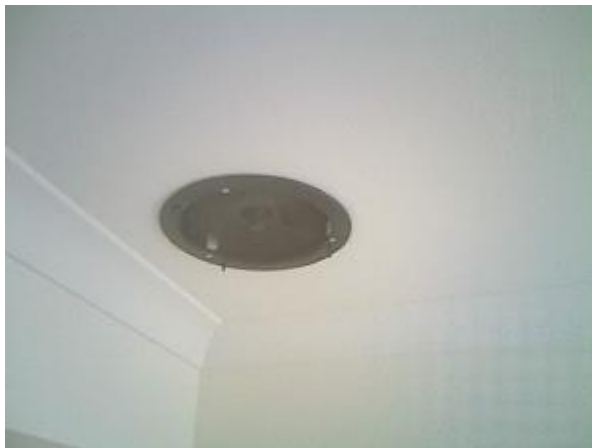
Ventilation

Missing grille

Minor Defect

Type: F

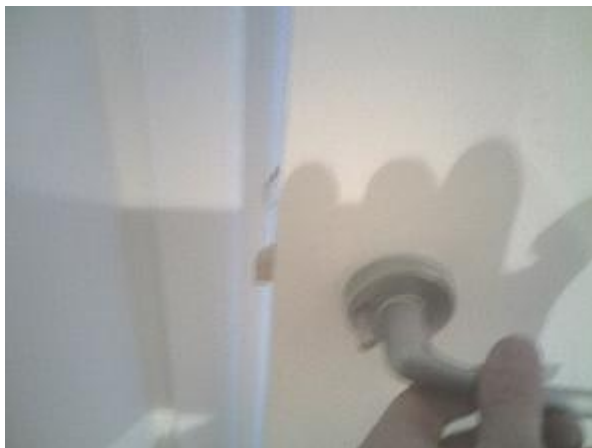
Doors and frames

Binding doors

Minor Defect

*Door requires trimming.*

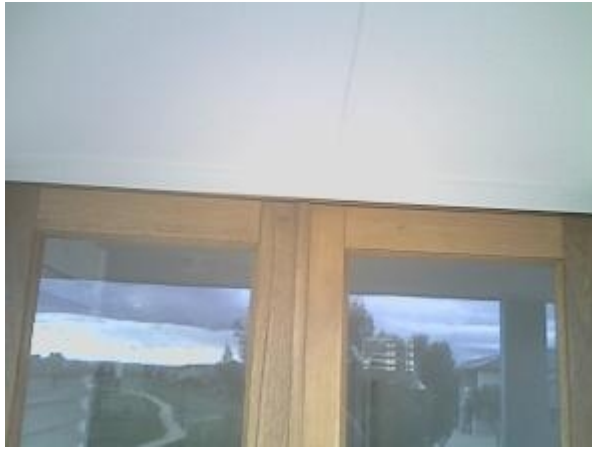
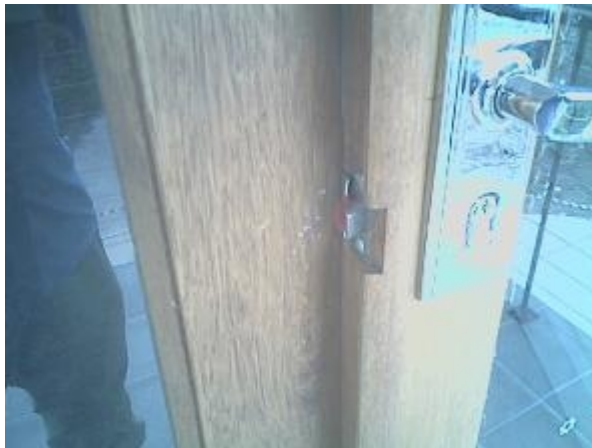
Doors and frames

Door frame out of square

Minor Defect

Type: A, F

*Adjustment required, including possibly trimming the door down. Re-sealing will be required.*

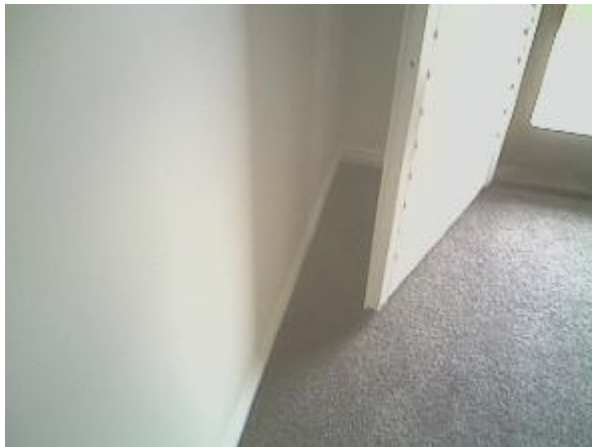
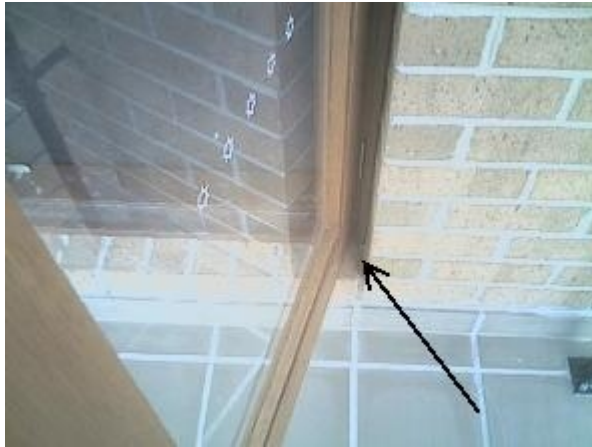
Doors and frames

Missing door stop

Minor Defect

*To either side of balcony door.*

**Interior > Bedroom 1 > Doors and frames > Missing door stop**

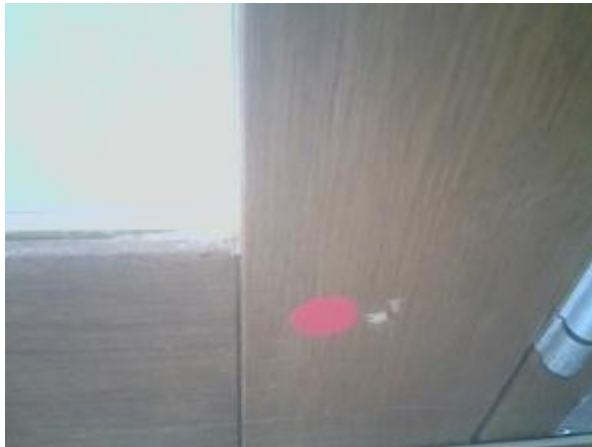
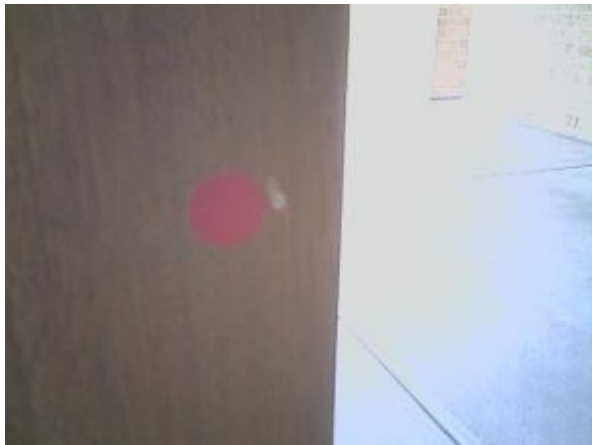
Doors and frames      Damaged doors      Minor Defect      Type: A  
*Occurs to bi-fold doors.*

**Interior > Dine > Doors and frames > Damaged doors**

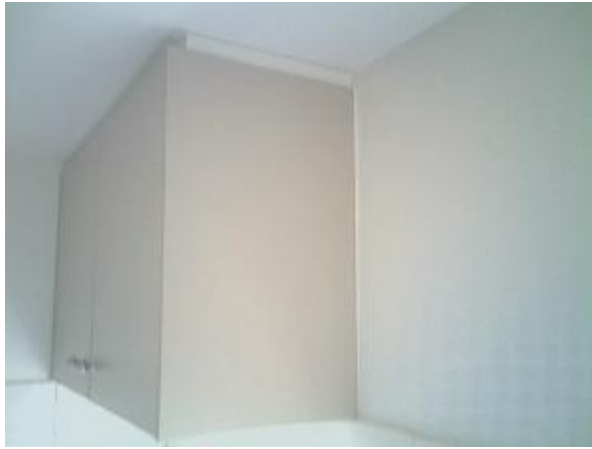
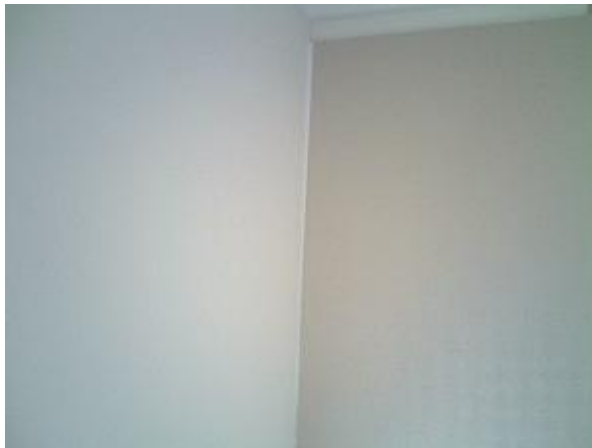
Walls      Out of plumb/Not straightened prior to plasterboard installation      Minor Defect      Type: F  
*Silicone sealant is uneven at wall/cupboard junction. The rangehood should cover this defect.*

Silicone sealant is uneven at wall/cupboard junction. The rangehood should cover this defect.

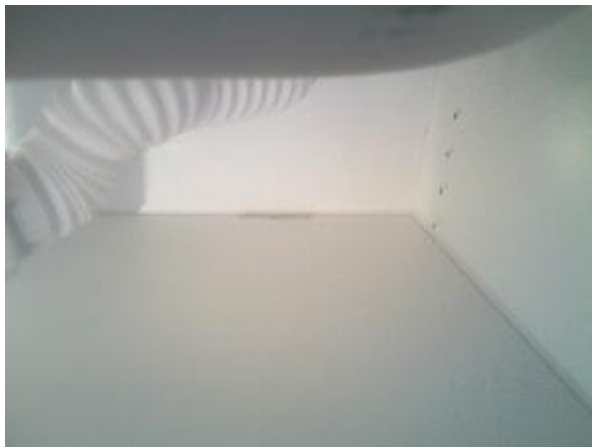
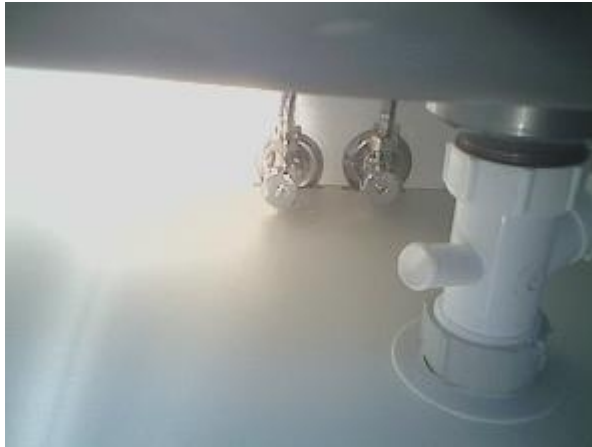
Trough cabinet/cupboard Damage to shelf

Minor Defect

*Cut outs to shelf have occurred due to the water supply points installed. Shelving could have been reduced to prevent this.*

**Interior > Laundry > Trough cabinet/cupboard > Damage to shelf**

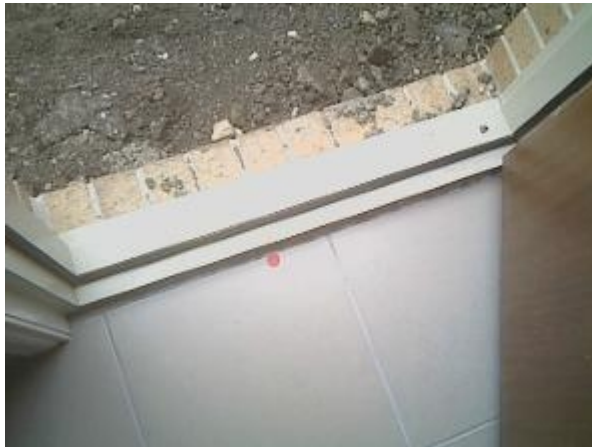
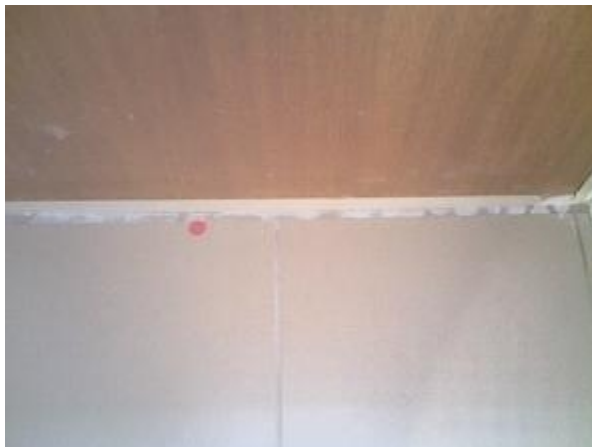
Tiles                                      Tiling setout incorrect                                      Minor Defect                                      Type: F  
*Tiling has been installed incorrectly, hence, a large grout joint has resulted that is not up to standard. Refer standard codes and tolerances document published by the Building Commission. Re-tiling should occur.*

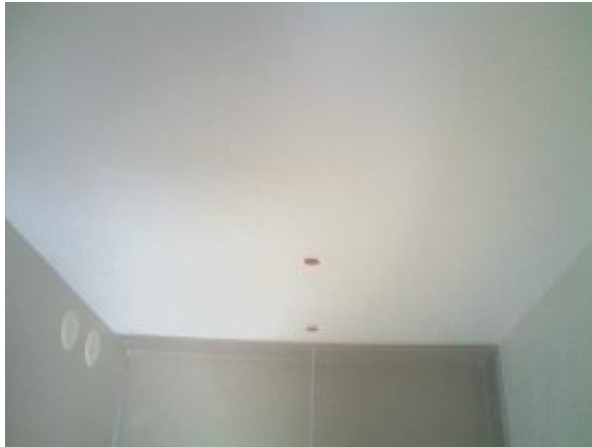
Walls                                      Not straightened prior to plasterboard installation                                      Minor Defect                                      Type: F  
*Wall should have been straightened prior to plasterboard installation.*

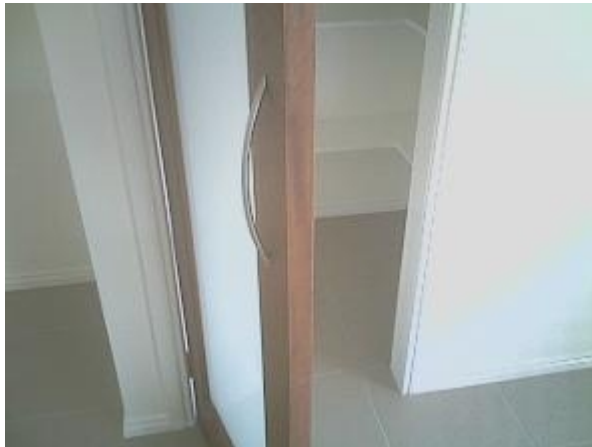
Doors and frames

Defective door hardware

Minor Defect

**Interior > Pantry > Doors and frames > Defective door hardware**

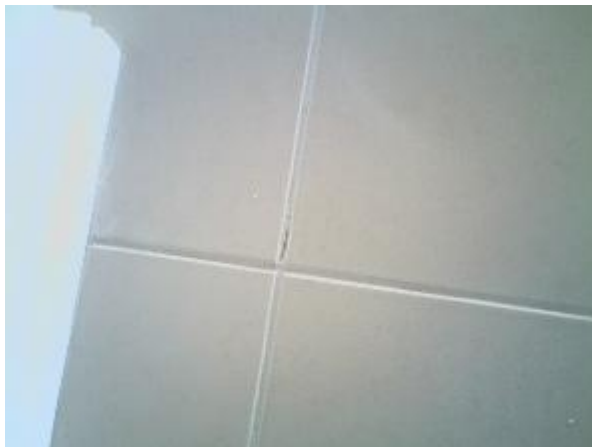
Floors

Missing grout

Minor Defect

*Occurs close to laundry entry in the main entrance hallway.*

**Interior > Passages > Floors > Missing grout**

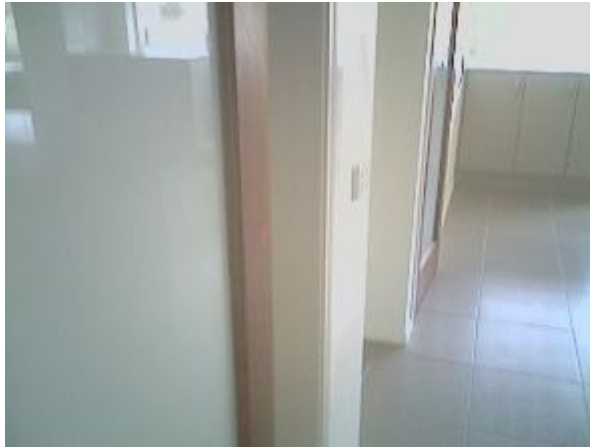
Doors and frames

Missing door furniture

Minor Defect

*Occurs at entry into kitchen.*

**Interior > Passages > Doors and frames > Missing door furniture**

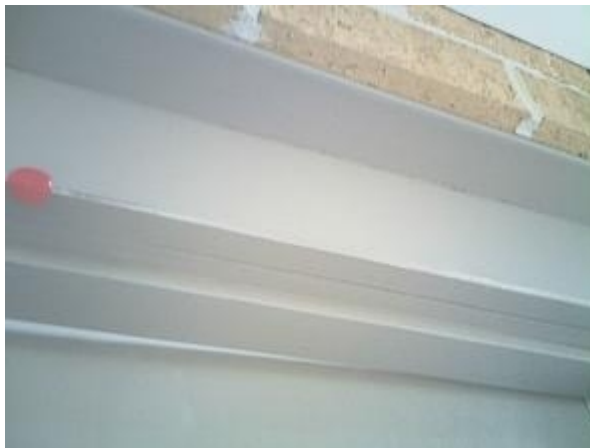
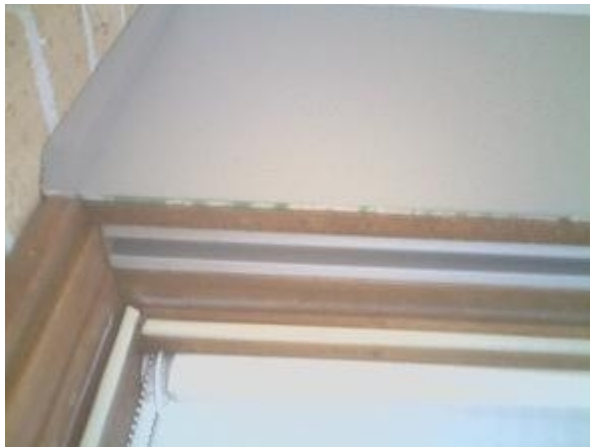
Doors and frames

Raw edges to door trims

Minor Defect

*Occurs to front entry door and rear bifolds.*

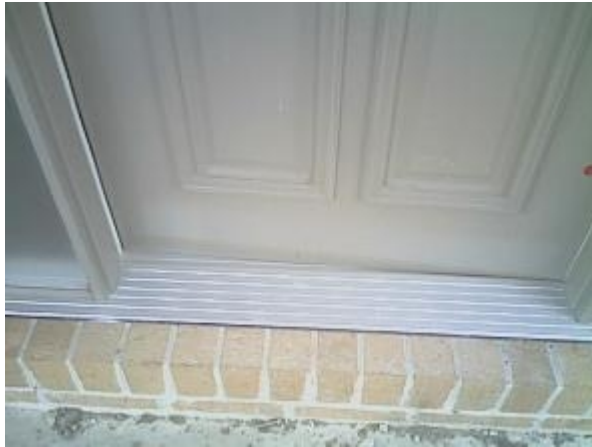
Doors and frames

Door frame out of square

Minor Defect

*Front entry door frame is out of square and requires rectification. Damage and poor finishing is also apparent. The door requires replacement. If the new door is trimmed to suit be weary of the dimensions between the decorative recess and the bottom of the door. If there is a significant difference it will be visible and if this is the case the jamb should be re-installed square.*

Front entry door frame is out of square and requires rectification. Damage and poor finishing is also apparent. The door requires replacement. If the new door is trimmed to suit be wary of the dimensions between the decorative recess and the bottom of the door. If there is a significant difference it will be visible and if this is the case the jamb should be re-installed square.

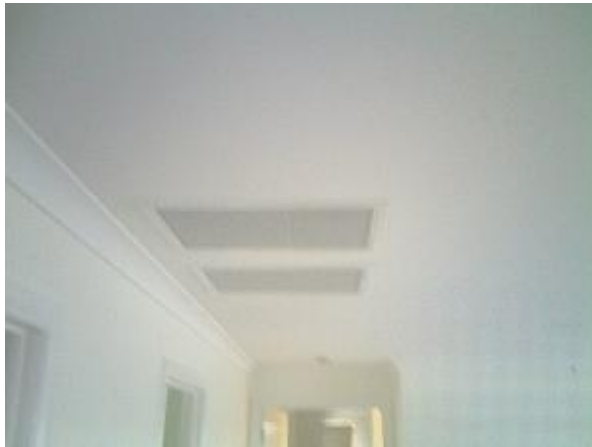
Ceilings & cornices

Return air vents do not line up

Minor Defect

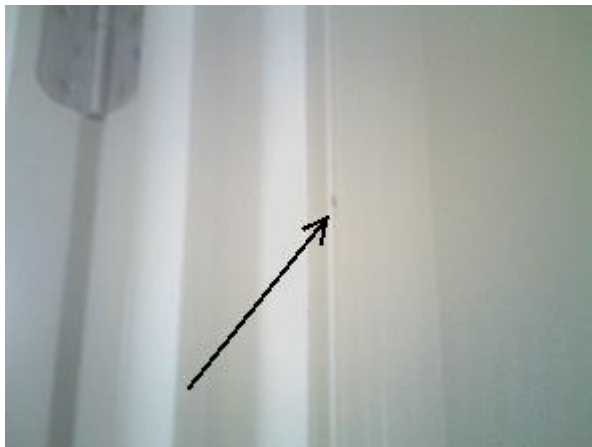
Doors and frames

Damaged jamb

Minor Defect

**Interior > Separate WC > Doors and frames > Damaged jamb**

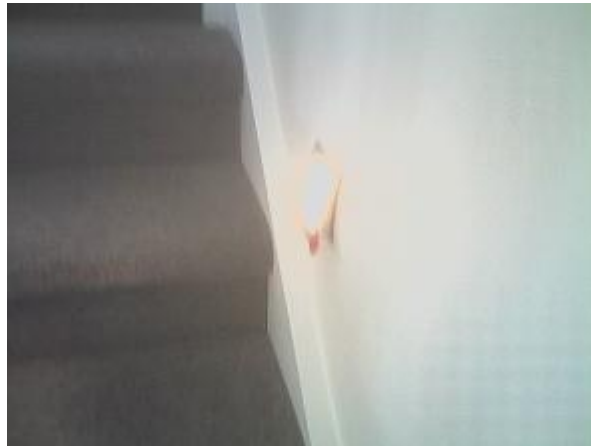
Light installation

Requires re-fitting

Minor Defect

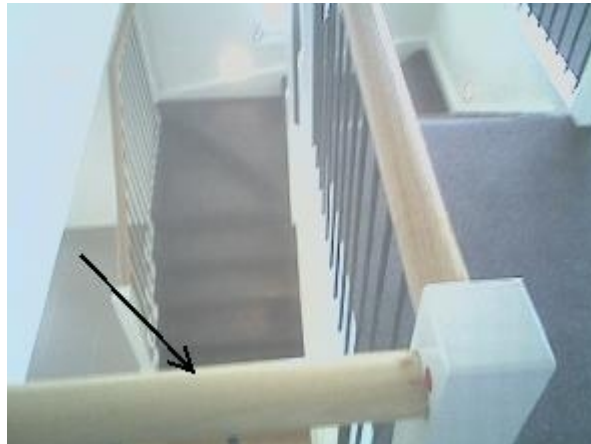
Handrail

Different colour handrails

Minor Defect

*Replacement of the handrail to the 1st level landing is required.*

Replacement of the handrail to the 1st level landing is required.

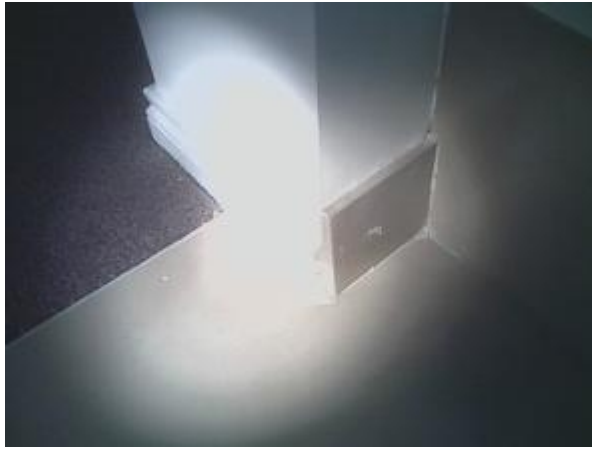
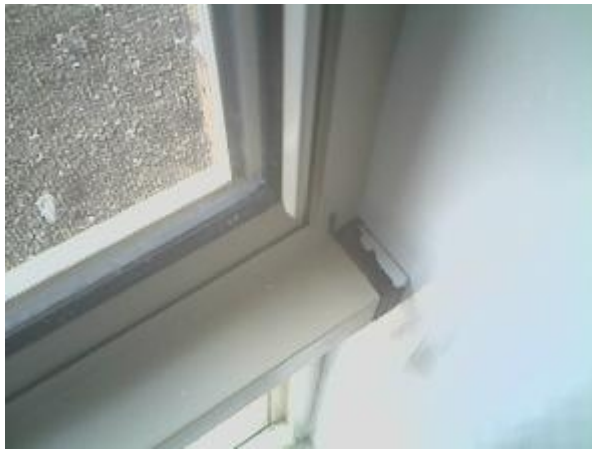
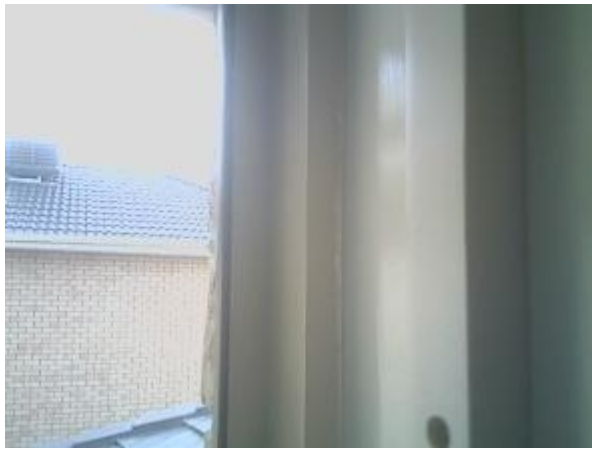
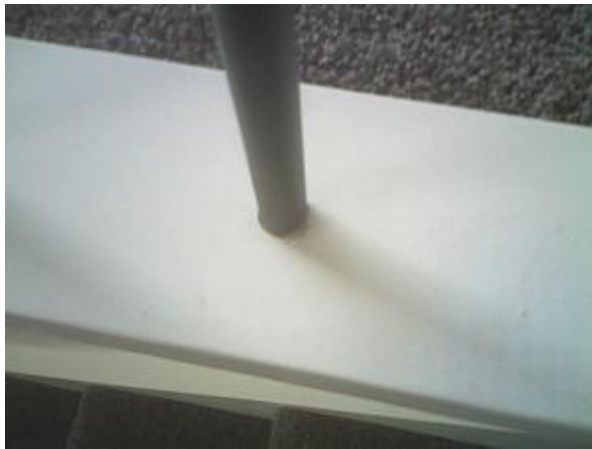
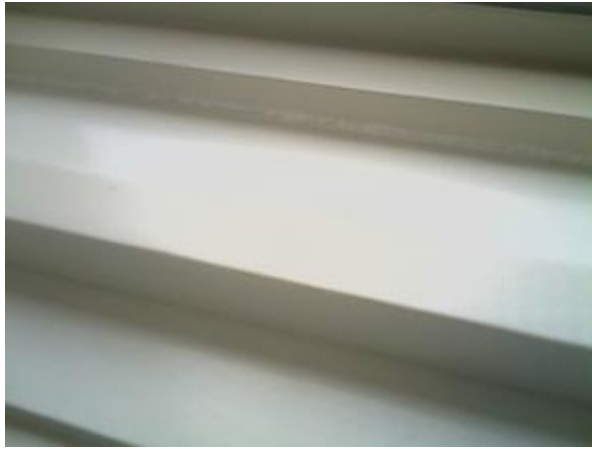
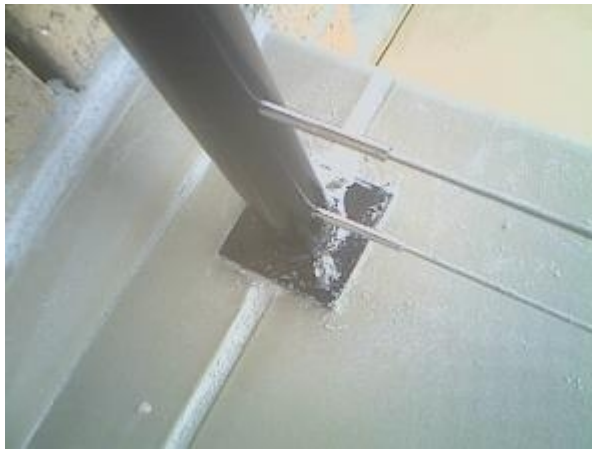
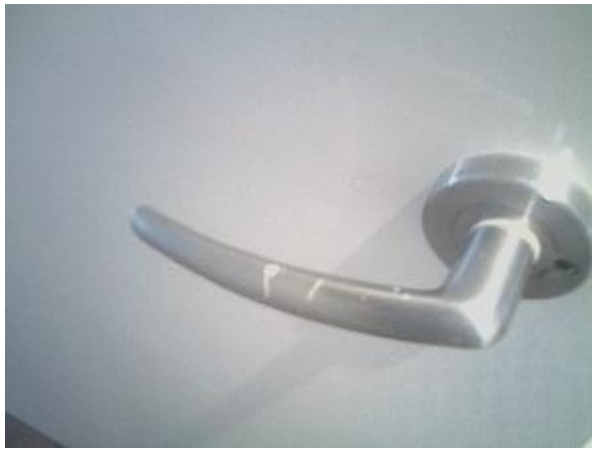
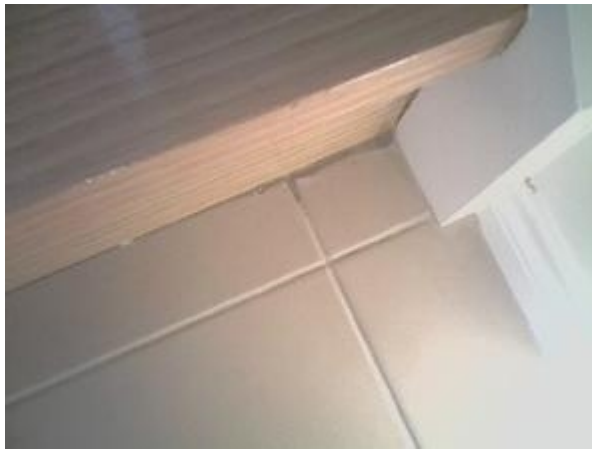
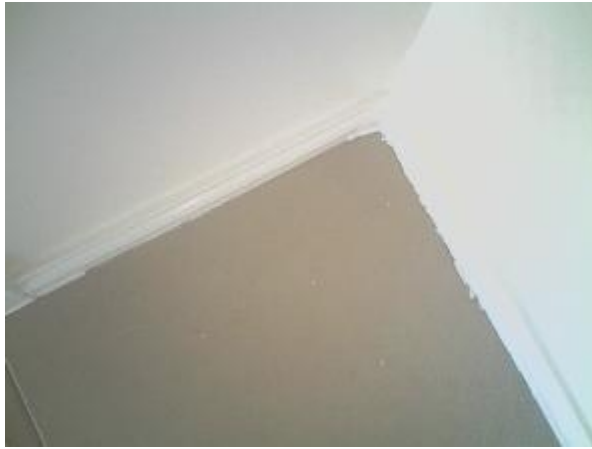
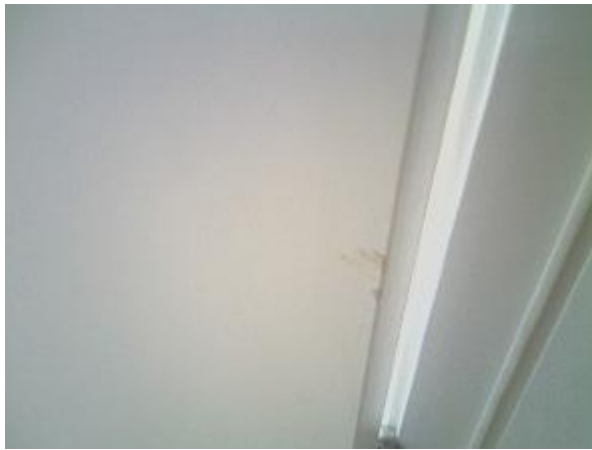
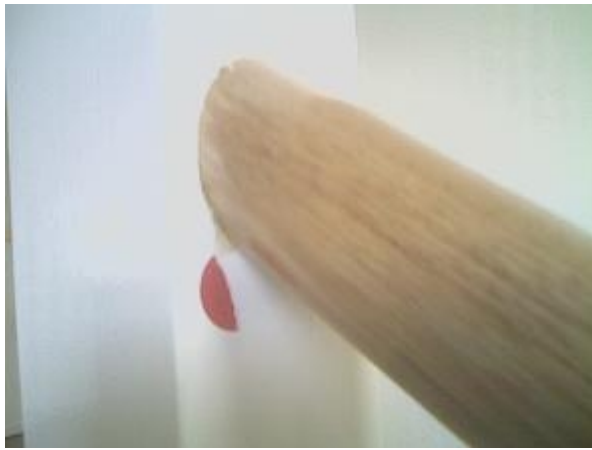
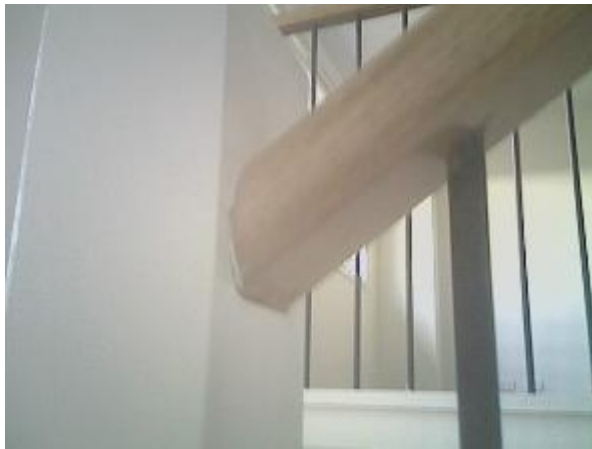
Miscellaneous items

Poor finishes/workmanship

*The items depicted in the photo's below literally occur in every room and/or passageway in the house. Items include paint spillages on to floors, walls, ceilings, doors & door frames and windows & window frames etc...*

*Particular examples are depicted only. There would be over 100 separate items in existence in this home some which have already been picked up via the client/builder walk through.*

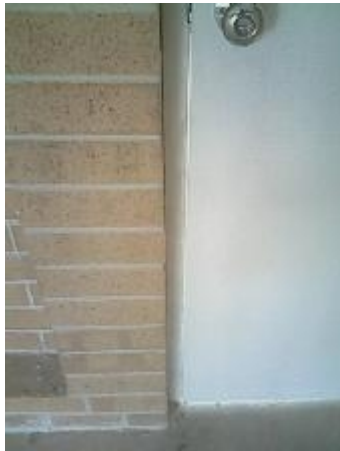
Doors & door frames  
*Trimming required.*

Out of square

Minor Defect

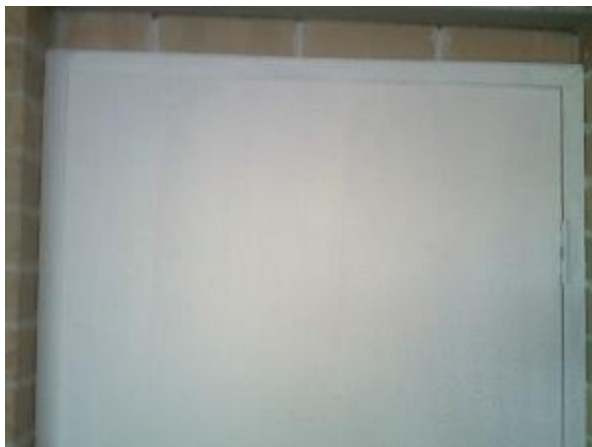
Doors & door frames

Requires additional coats of paint

Minor Defect

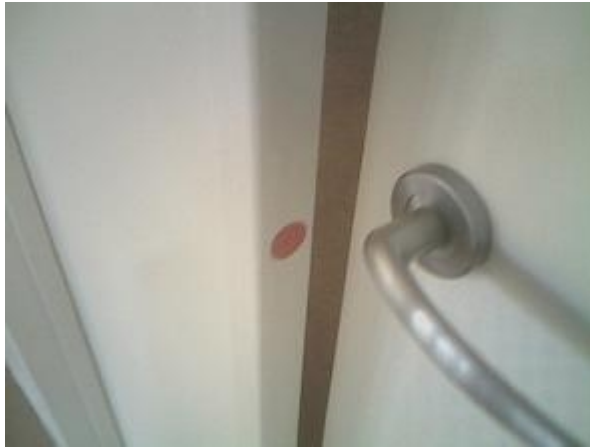
Doors & door frames

Missing door hardware

Minor Defect

**Interior > Theatre room > Doors & door frames > Missing door hardware**

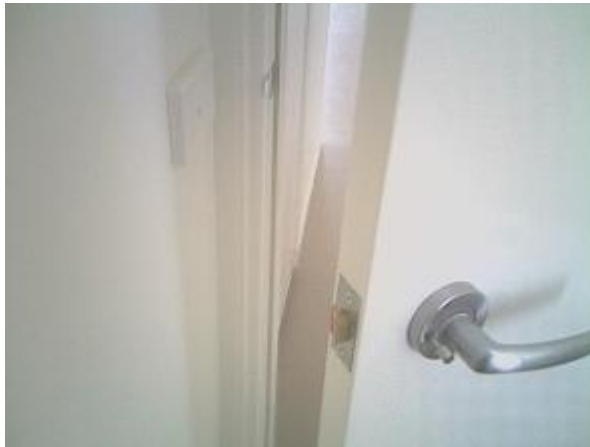
Doors & door frames      Door does not latch      Minor Defect      Type: F  
*Adjustment to striker plate required.*

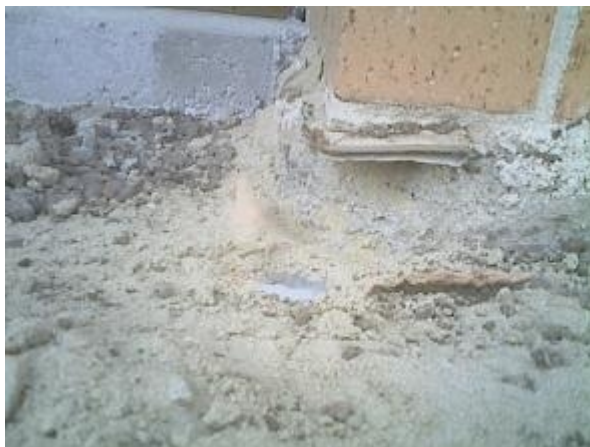
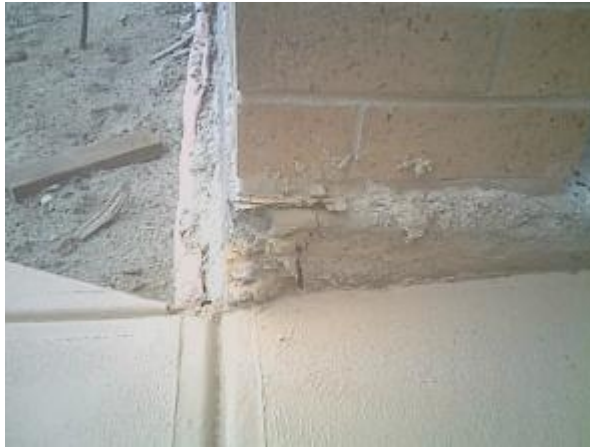
Walling      Brick overhang      Further Investigation      Type: F  
*Further investigation required by a structural engineer. Structural grout may be an option. A Structural engineer's certification is required. Occurs to right front entry column and left rear corner of the home looking from the front in.*

### Exterior > Default Elevation > Walling > Brick overhang

Further investigation required by a structural engineer. Structural grout may be an option. A Structural engineer's certification is required. Occurs to right front entry column and left rear corner of the home looking from the front in.

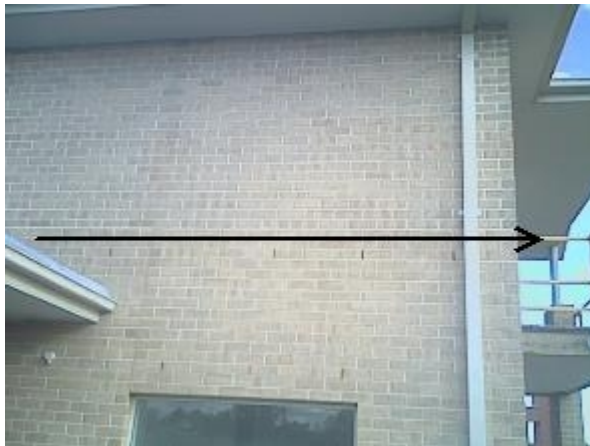
Walling                                      Colour differentiation to all elevations      Major Defect                                      Type: F

*All external walls exhibit a change in colour and this occurs approximately 2 courses above the weep holes of the 1st level floor. Brickwork requires replacement. This is a major process involving removal of the brickwork to the 1st level and re-installation.*

*Furthermore, my client has stated that the colour of brick chosen pre-contract was the colour of the bricks on the 1st level. In this case the bricks to the ground level area are the wrong colour. Technically, all bricks require replacement.*

*As this is a contractual issue, further investigation should be carried out by a legal practitioner.*

### Exterior > Default Elevation > Walling > Colour differentiation to all elevations

All external walls exhibit a change in colour and this occurs approximately 2 courses above the weep holes of the 1st level floor. Brickwork requires replacement. This is a major process involving removal of the brickwork to the 1st level and re-installation.

Furthermore, my client has stated that the colour of brick chosen pre-contract was the colour of the bricks on the 1st level. In this case the bricks to the ground level area are the wrong colour. Technically, all bricks require replacement.

As this is a contractual issue, further investigation should be carried out by a legal practitioner.

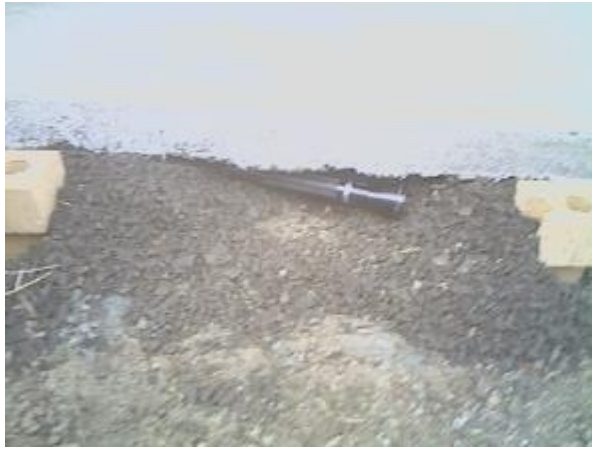
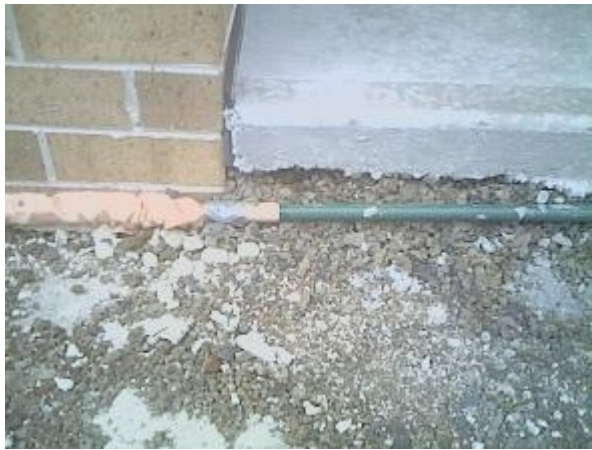
Perimeter paths                                      External concrete slabs                                      Major Defect                                      Type: F

*Have been laid on loose, uncompacted crushed rock. Further investigation and certification is required by a structural engineer.*

Have been laid on loose, uncompacted crushed rock. Further investigation and certification is required by a structural engineer.

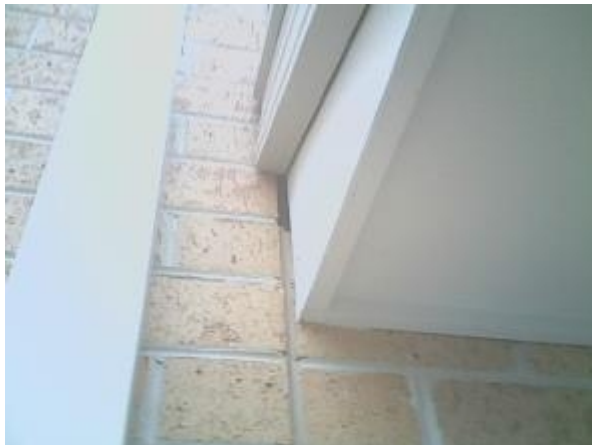
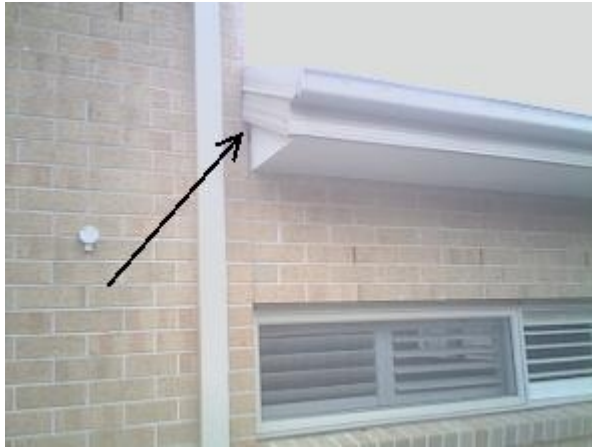
Walling

Missing caulking

Minor Defect

**Exterior > East Elevation > Walling > Missing caulking**

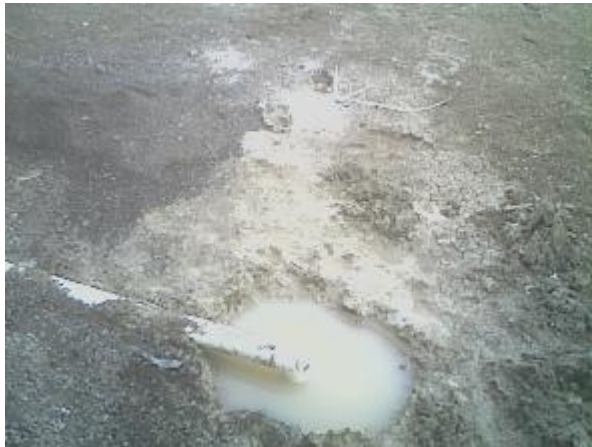
Plumbing                      Leakage to stormwater drainage pipe    Minor Defect                      Type: A  
*Repair required asap to prevent subsidence of footings.*

**Exterior > Other Features > Plumbing > Leakage to stormwater drainage pipe**

Repair required asap to prevent subsidence of footings.

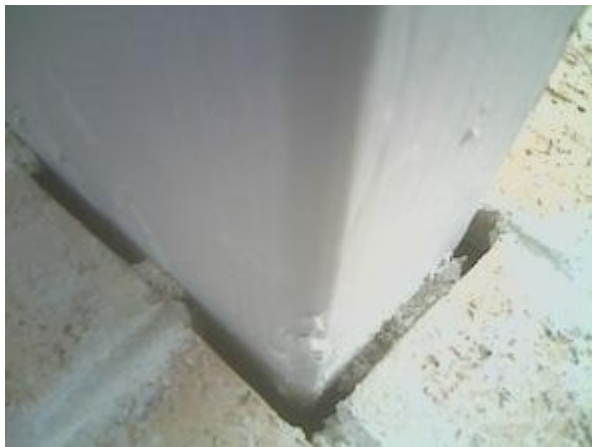
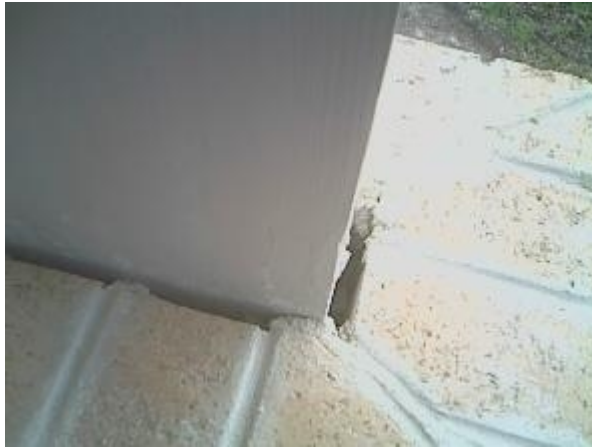
Structural columns              Missing caulking                      Minor Defect                      Type: F  
*Caulking is required asap. Rot will occur to timber columns.*

**Exterior > Stairs, decks, balconies > Structural columns > Missing caulking**

Caulking is required asap. Rot will occur to timber columns.

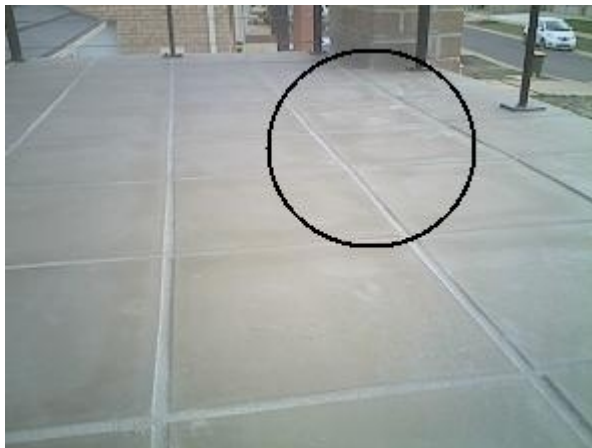
Balcony decking

Low spot in tiles

Major Defect

*Water will pond. Rectification will include re-tiling.*

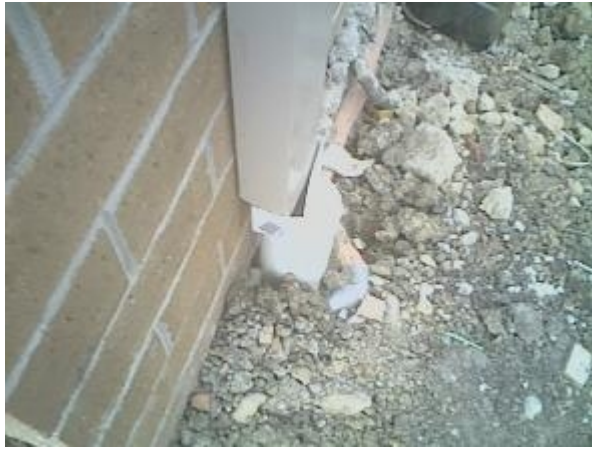
Down pipes

Not connected to storm water system

Minor Defect

*Due to the incorrect installation of the stormwater pipe at ground level.*
