Melbourne Property Inspections P/L

Residential Pre-purchase Inspection Report

Date of inspection: Sunday, 01 February 2009 01:45 PM

Property address	7 XXXXXXXX Street GLEN IRIS VIC 3146
Report prepared for	Sample Sample XXXXXXX Street MOONEE PONDS VIC 3039
Client's contact details	Mobile 1234 567 890 Home (03) 7345 6789 homebuyer@melbourne.com.au
Real estate agent's details	Name XXXXXXXX XXXXX Company XXXXXXXX XXXXXXXX Mobile 1234 567 890 Office (03) 1234 5678
Type of inspection report	Standard Inspection, Complete
Persons present	Pest Inspector, Agent's Representative
Weather Conditions	Fine
Inspector	Joseph Noto, BA App. Sci. (Construct. Mgt) (Eco.) Domestic Builder - Unlimited DB-U 28857

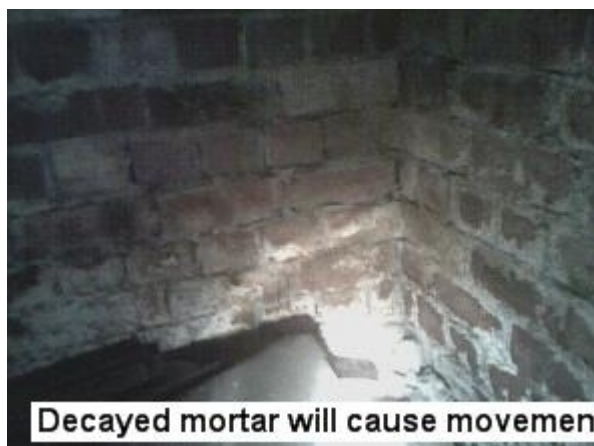
Type: C

In this case rising damp has begun deteriorating the sub-floor masonry walls. Floor bearers are bear load onto these walls. Rectification of rising damp is required immediately.
